## 7.2 EROSION OF THE OLIFANTSFONTEIN WETLAND AND THE SEDIMENTATION PROBLEM

### **7.3 EROSION OF SECTIONS ALONG THE HENNOPS RIVER AND ITS FEEDER STREAMS**

#### 7.4 DEBRIS: URBAN LITTER AND VEGETATION

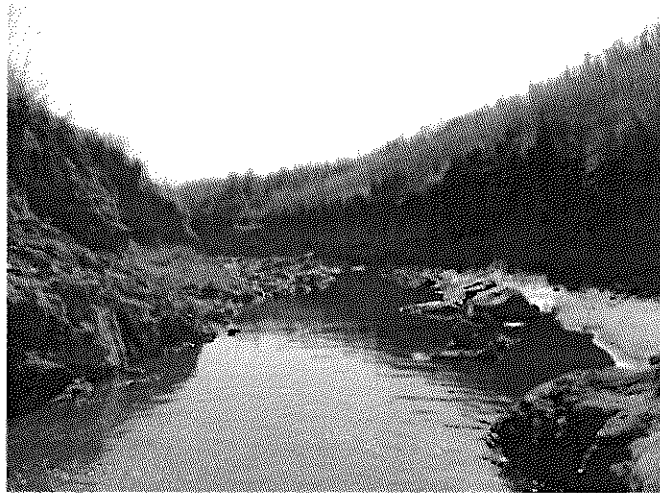
**Figure 28: Olifantsfontein wetland erosion channel**

According to George (2003) the Olifantsfontein wetland appears to be the remains of a much larger wetland which is thought to have had a surface area of some 50 ha. Visual observation reveals that the size of the wetland has substantially decreased in size to approximately 10 to 15 ha in extent. It was also determined that the present-day condition of this wetland is not in a condition conducive for the above-mentioned functions i.e. this wetland is not functioning as a true wetland mainly owing to it being drained by the erosion channel which cuts through the centre of it. This erosion channel is large, being 2 km long, 15 to 40 m wide and 3 to 6 m deep (**Figure 28**).

George (2003) believes that the rate of erosion will probably reduce with time, once the river has established a new gradient through the wetland and lateral erosion (channel widening) has extended far enough to accommodate the largest floods albeit that this process is likely to still take a long time.

- Untreated waste water (see **Figure 11**, p 37) is also released into the Clayville tributary from the industrialised area which ultimately affects the growth of vegetation downstream at the start of the wetland.
- The Kaalspruit's course through the wetland being a 5 to 6 m deep erosion channel (**Figure 28**) has, according to George (2003), lowered the water table in the wetland resulting in the drying-up of the larger wetland.
- Owing to the drier conditions, veld fires are damaging the reedbeds even further.

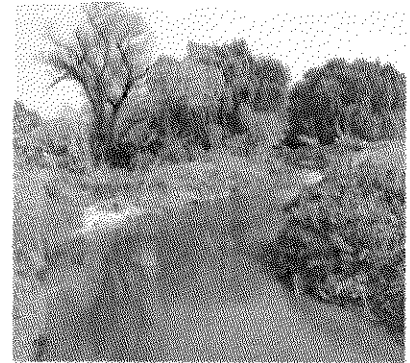
**Figure 29: Olifantspruit at Irene bridge**

In terms of *environmental* impacts the sedimentation according to George (2003), has filled many of the deep pools and channels with sand and silt in these rivers (**Figure 29**) thereby either destroying or degrading the habitat and life-support systems of fish and invertebrates (see section 2.4, p 24). As a result animals higher up in the food web such as birds and otters have been negatively impacted upon. Aquatic environments, especially their biota, are negatively affected by sediment loads either in suspension, after deposition or by both as discussed in section 2.4, p 24.

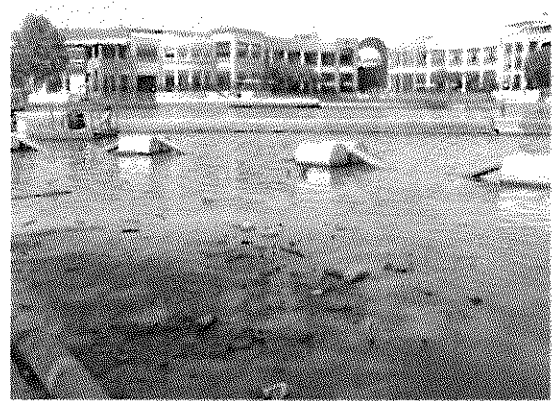
**Figure 30: Centurion Lake siltation**

Studies conducted by George (2003) show that the former Centurion Town Council estimated that after Centurion Lake's construction in 1982 up to the end of 1994 approximately 43 000 m<sup>3</sup> of sediment accumulated in the lake. It can therefore be said that during this period an annual sediment volume of 3 500 m<sup>3</sup> accumulated in it. From December 1994 to April 2000 the amount of sediment deposited in the lake increased to approximately 120 000 m<sup>3</sup> at which point the lake was almost completely silted up as the lake has a volume of 145 000 m<sup>3</sup>. The average sediment

volume had therefore increased to 12 833 m<sup>3</sup>/a and George (2003) believes the volume could even reach 15 000 m<sup>3</sup>/a.

Being an affected urban impoundment in the centre of Centurion's CBD, the Centurion Lake has inevitably also had an impact on the social sphere of the environment. As discussed in **Chapter 3**, the lake was constructed in 1982 for aesthetic and recreational purposes. A musical fountain constructed in the middle of the lake attracted large numbers of people during the eighties and nineties to the shopping complex. This attraction no longer exists due to the sedimentation problem. Complaints concerning odours and aesthetics of the lake have also become frequent since the mid-nineties. The number of people utilising the braai facilities on the northern side of the lake has also decreased as it became unpleasant visiting the lake in its deteriorated state. Recreational uses of the lake which included boat cruises, paddle boats, canoeing, windsurfing, rowing, angling and swimming (Freeman *et al.*, 2000) have ceased during the past 15 years due to the lake's water quality and it becoming too shallow in certain areas as sediment loads have gradually filled most of it.

*Economic* impacts borne from the Centurion Lake's sedimentation problem include major expenses needed for its restoration/rehabilitation of the Centurion Lake. As discussed in section 8.4, p 109 Pienaar (2004) mentions that sediment/silt is continually pumped out of the lake at a cost of R2,5 million per annum. The sediment/silt are conveyed via a pipeline to be deposited in a built silt deposit dam and the costs involved for this amounted to R8,1 million.

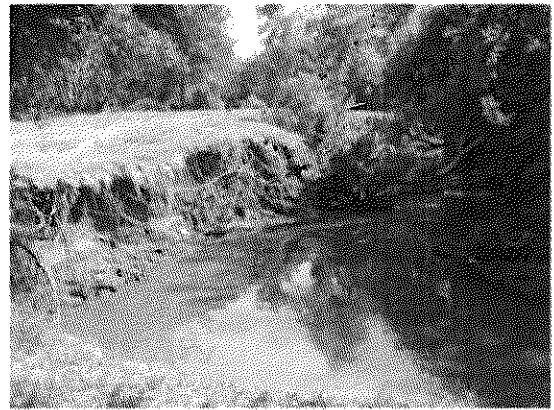
**Figure 31: Erosion of riverbank**

Even though the Centurion Lake traps approximately 75 % of sediment loads, erosion of riverbanks and river widening were also observed along sections of the Hennops River downstream of the lake. Since most sediment loads are trapped by the lake the increase in stormwater run-off augmented from Centurion's urbanised areas into the Hennops must be the significant factor of erosional activity taking place. This additional run-off is produced by *inter alia* the watering of gardens, backwashing of pools and leaking water supply lines.

The researcher is of the opinion that the erosion problem is greater upstream from the lake than sections downstream from it. Undercutting of riparian vegetation and the silting-up of the lake are problems having direct impact on the natural environment, social and economic spheres. The eroded sections downstream from here go unnoticed by most people such as residents in the area. Eroded sections of the Hennops River down to the end of the study area seem to be stabilised and as such, the rate of further erosional activity is low.

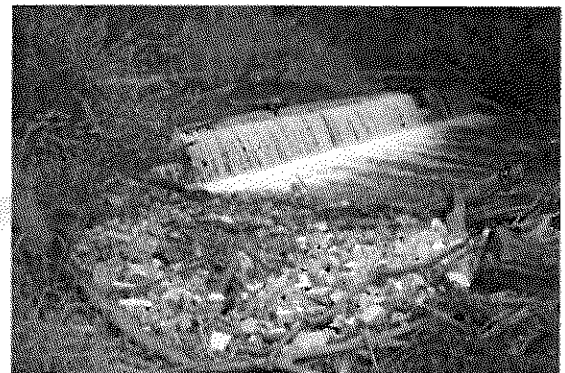
**Figure 30: Vegetation and urban litter debris**

- *Urban litter debris* ranging from cans, bottles, plastic bags, clothing, tyres, shopping trolleys including dead animals, and
- *Vegetation debris* comprising largely of branches and trees (**Figure 30**).

The Kaalspruit receives urban litter from Tembisa and its surrounding areas due to the lack of proper waste collection, handling and removal services. The Olifantspruit does not receive high amounts of litter except near roadside bridges and gutters flanking the spruit. The Hennops River's urban litter volumes are not as high as the Kaalspruit's but still remain an environmental and social problem. Urban litter is also found along the Hennops where it flows under bridges, busy roads and residential areas – upstream and downstream of the Centurion Lake.

*Vegetation debris* is found in the Olifantspruit and Hennops River – mostly upstream from the Centurion Lake. The erosion of riverbanks, as discussed in section 7.3, p 97 also contributes to the undercutting of riparian vegetation resulting in such vegetation to collapse into these rivers. The vegetation ranges from small shrubs and tree branches to larger tree trunks such as *P. canexens*. The problem with vegetation debris is that it accumulates against most obstructions

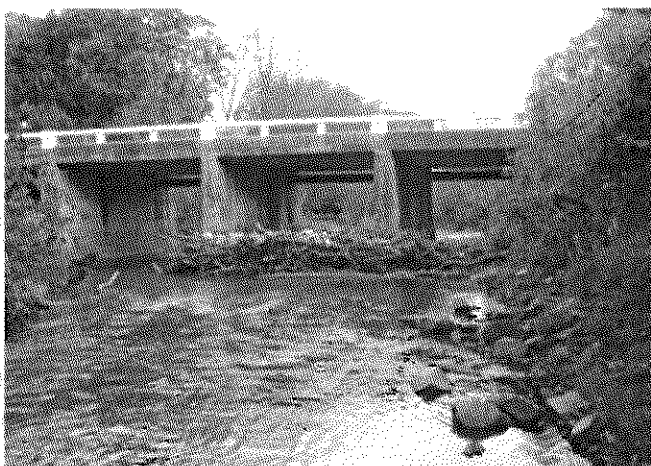
**Figure 31: Vegetation and urban litter debris blocked by bridge**

(depending on river flow volumes) such as protruding rocks, river bends, weirs and bridge supporting structures (**Figure 31**). This, in turn, affects the river flow regime and habitat for aquatic biota negatively as river flow is impeded and riverbeds and riverbanks become blocked with debris which limits available space and sunlight needed especially by benthic life forms.
