# The proposed Kaalspruit Open Space Project, Thembisa, Gauteng

## Kaalspruit River Rehabilitation

### Biodiversity Scan: Vegetation and vertebrate report

# AN ASSESSMENT OF THE FLORA, HABITATS AND VERTEBRATE FAUNA EXPECTED ALONG THE PROPOSED KAALSPRUIT WATERCOURSE REHABILITATION IN TEMBISA, JOHANNESBURG

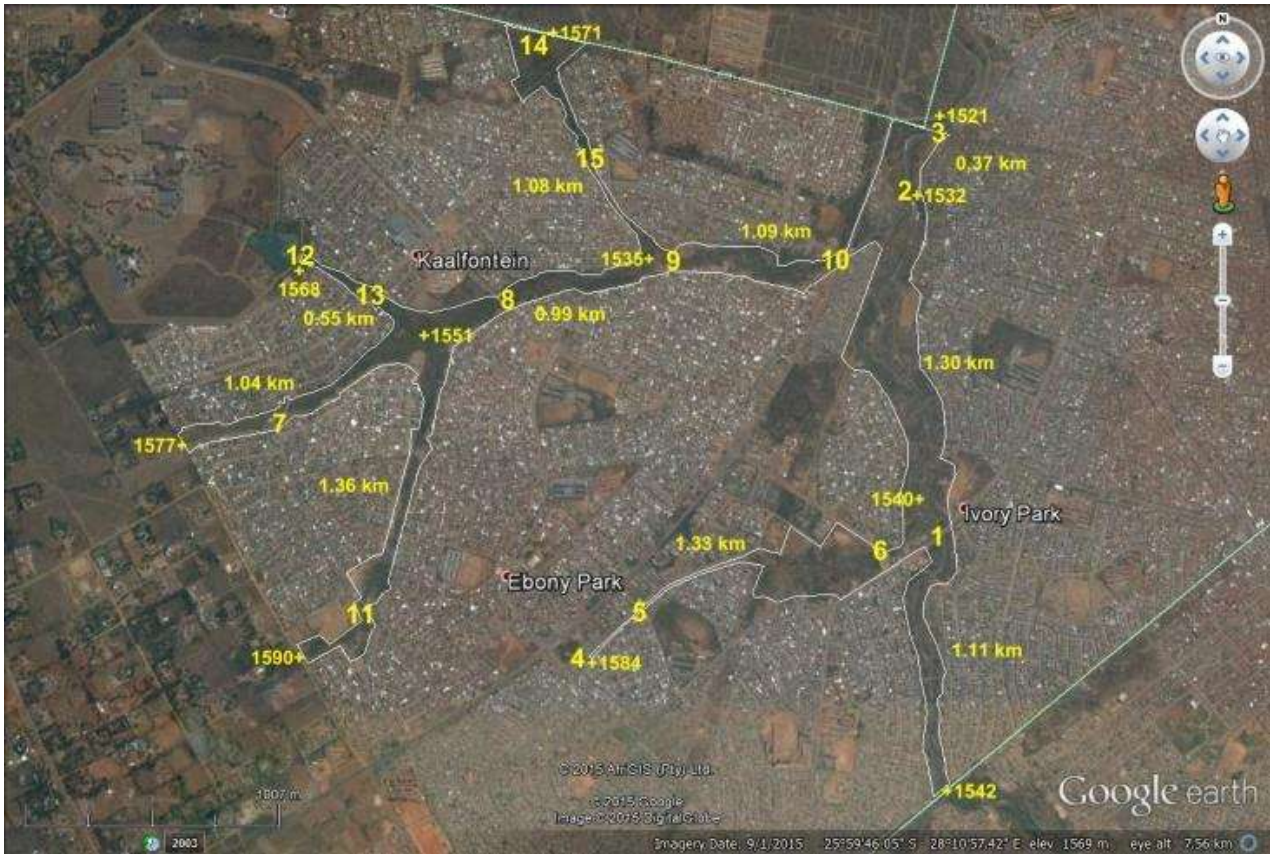
Figure 8: Sequence of positions for images taken to show the main features of each of the drainage systems involved along the mainstem Kaalspruit and its tributaries, starting each one upstream and ending downstream. Altitudes at points along the system are indicated as m a.s.l. (taken from Google Earth), and the straight-line distance between these points (+) as kilometres, to allow estimation of gradient. The estimated source of the Kaalspruit is at 1690 m a.s.l. and 7.37 km straight-line upstream of the study area.

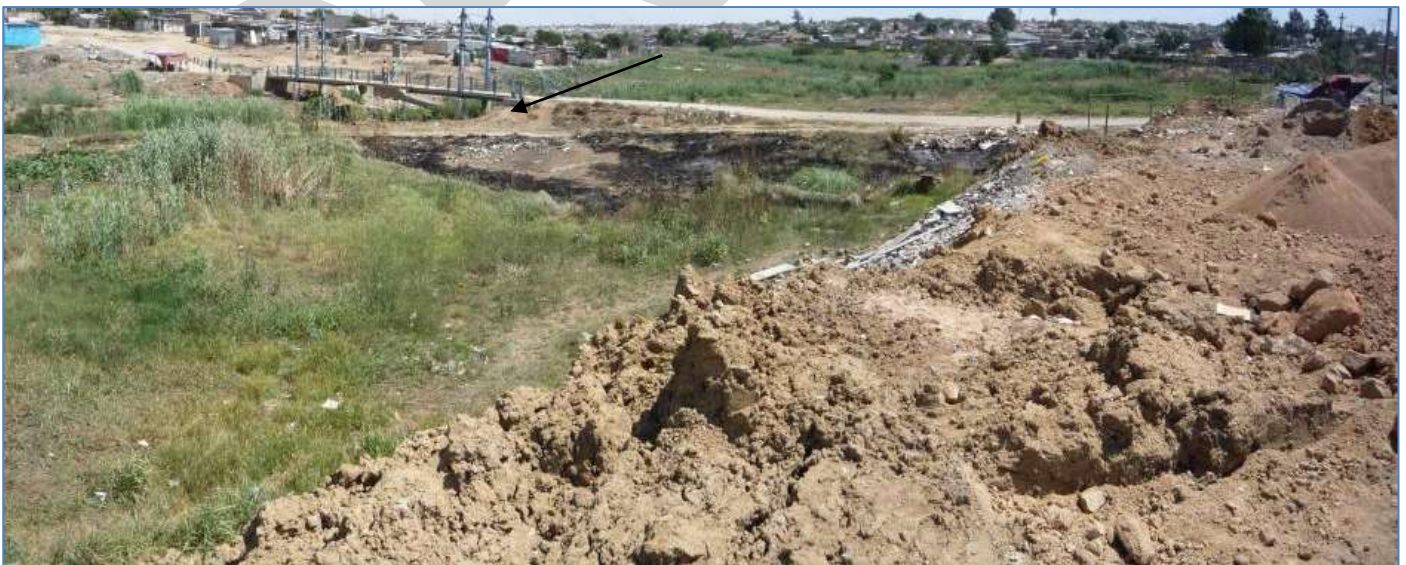
Figure 9, position: 1: View south (upstream) from an earth landfill into the west bank of the Kaalspruit River, west of its crossing of Freedom Drive, showing the reedy watercourse, grassy banks and low gradient upstream, with a pedestrian bridge and in the distance the southwestern Johannesburg-Ekurhuleni boundary. Note the constrictions on either side from the pedestrian walkway embankments.

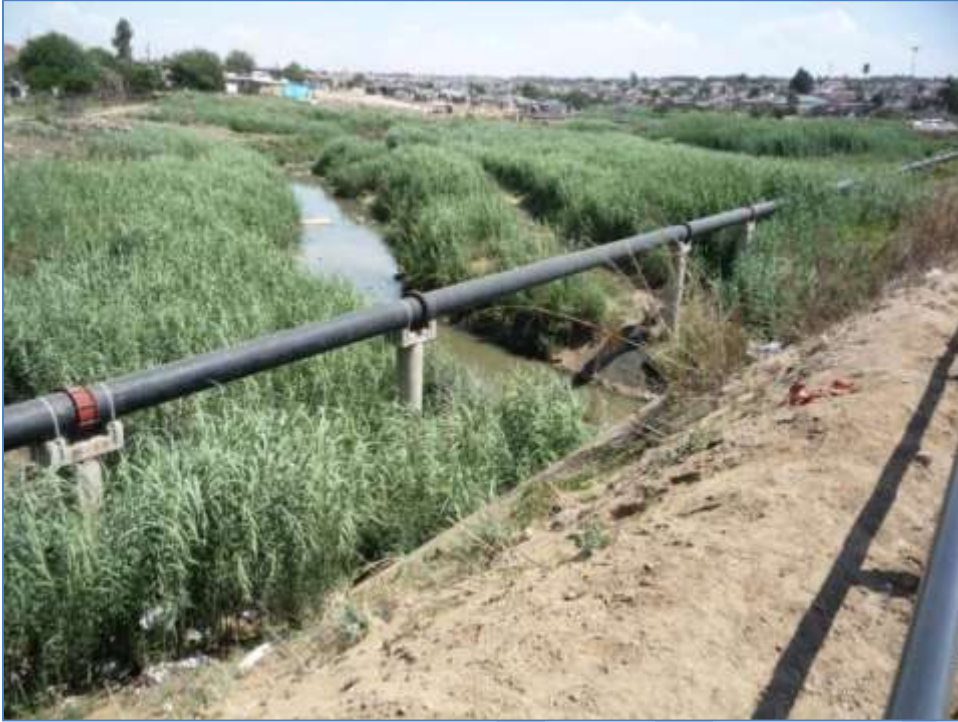
**Figure 10, position 1: View south (upstream) from the crossing of the Kaalspruit River over Freedom Drive, showing the reed-filled watercourse, with a pipeline crossing in the foreground and the pedestrian crossing in the distance. Note the stream restricted to only one of several channels due to late rains. Note the damming effect of the road embankment (cf. Fig. 11).**

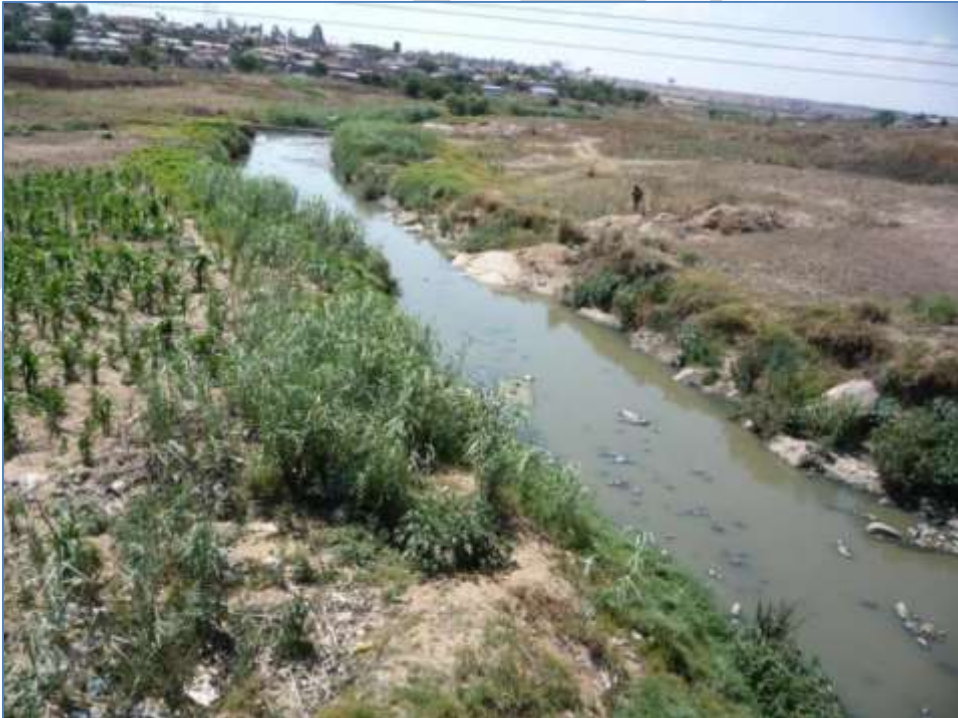
**Figure 11, position 1: View north (downstream) from the crossing of the Kaalspruit River over Freedom Drive, showing the single bed, with the watercourse cleared of most wetland vegetation by flooding and the banks by used as croplands watered from the river. The K1 tributary enters from the west (left) at the far end of the open water. Note the low weir further down the river.**

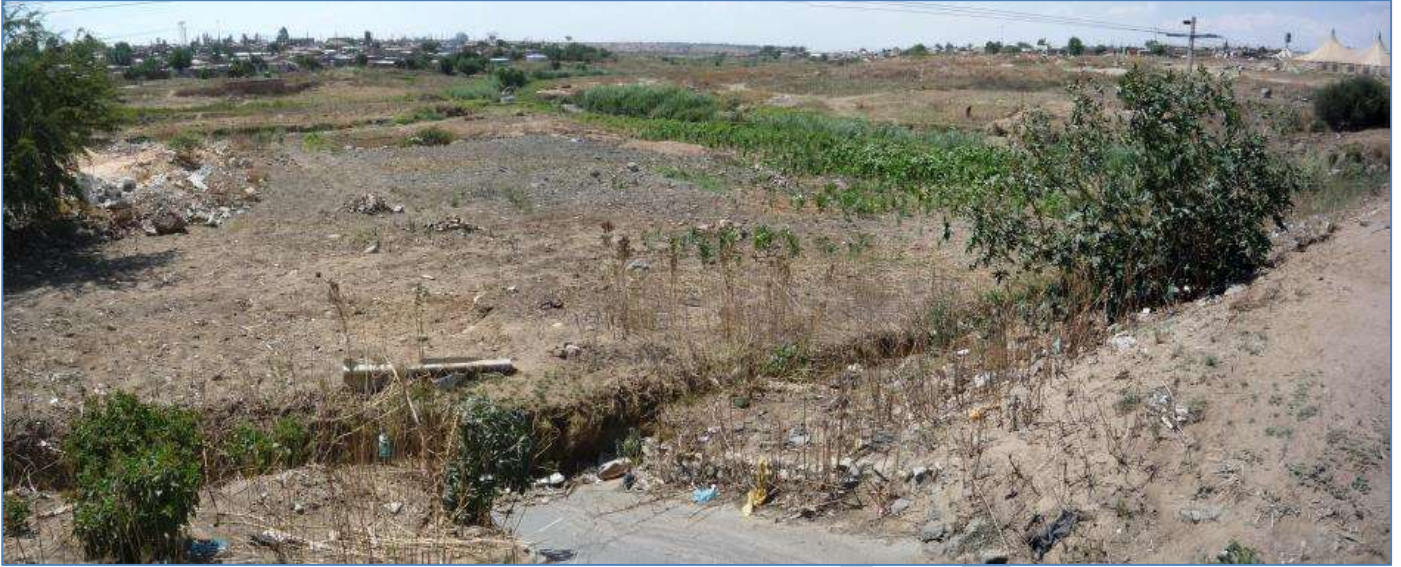
Figure 12: position 1: View north (downstream) from the western end of the Freedom Drive bridge, showing the line of the K1 tributary drainage entering the Kaalspruit from the west (left) in the distance, the green river-watered maize along the Kaalspruit bank and, in the foreground, the channel where runoff from the road drains into the watercourse. Note the design for and erosion from runoff from the road surface above (behind).

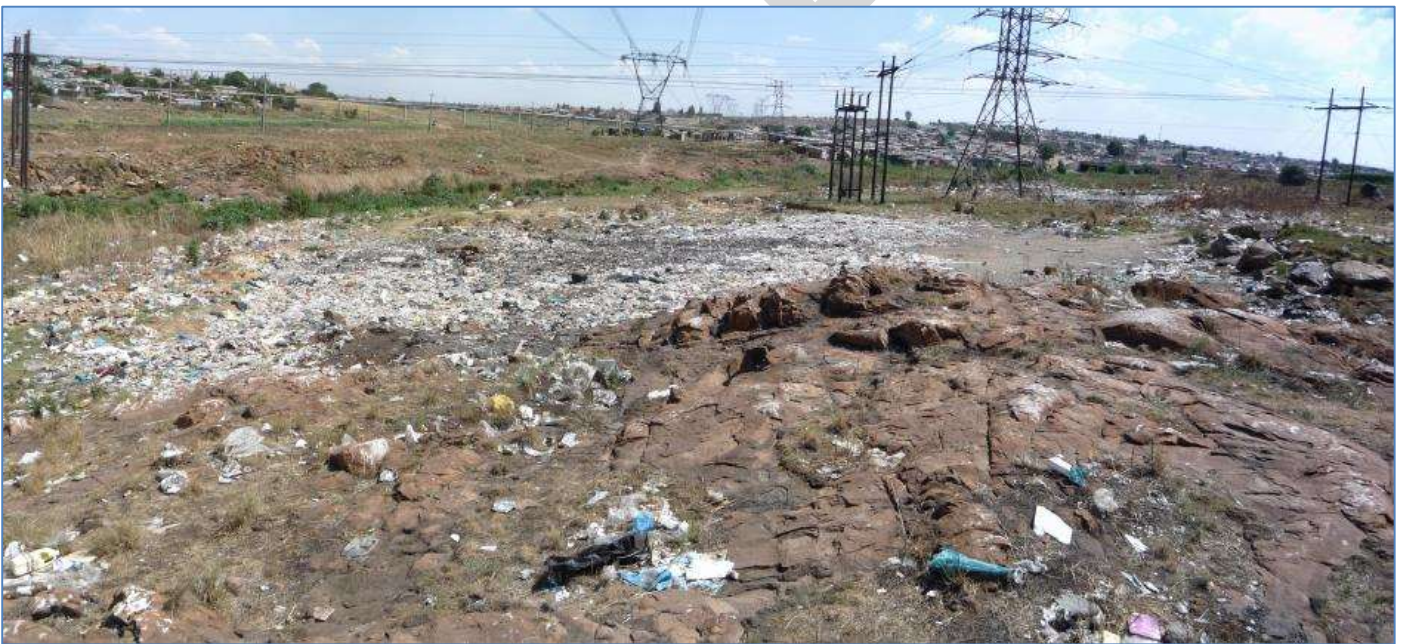
Figure 13, position 2: View south (upstream) of the lower section of the Kaalspruit on the study area, taken from a granite outcrop used as a dumping site for rubbish and rubble, and showing the relatively wide banks with secondary grassland near the river and small croplands closer to the eastern (left) houses. The K2 tributary from entering from the west (right; green strip) is channeled by the resistant outcrop into the Kaalspruit at this point, with the incised Kaalspruit bed visible just beyond. Note the various powerlines used as perches, and that the outcrop still supports a few *Xerophyta retinervis* lilies.

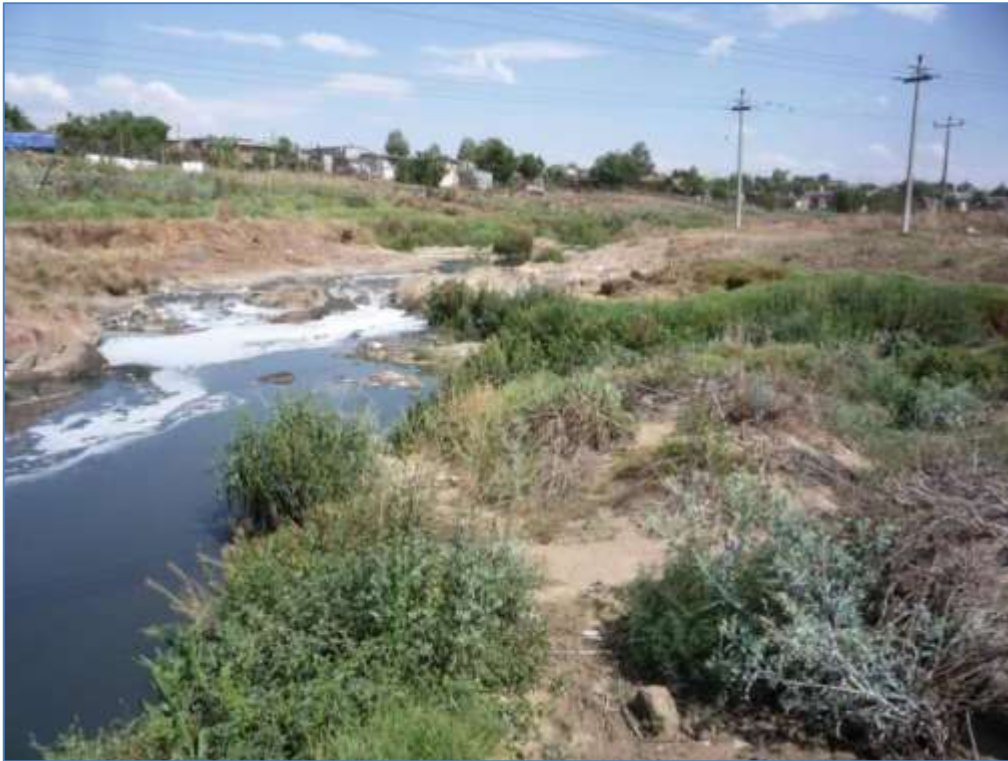
Figure 14, position 2: View south (upstream) of the steeper drop at the small rapids where the Kaalspruit has eroded through the resistant granite intrusion of Fig. 13.

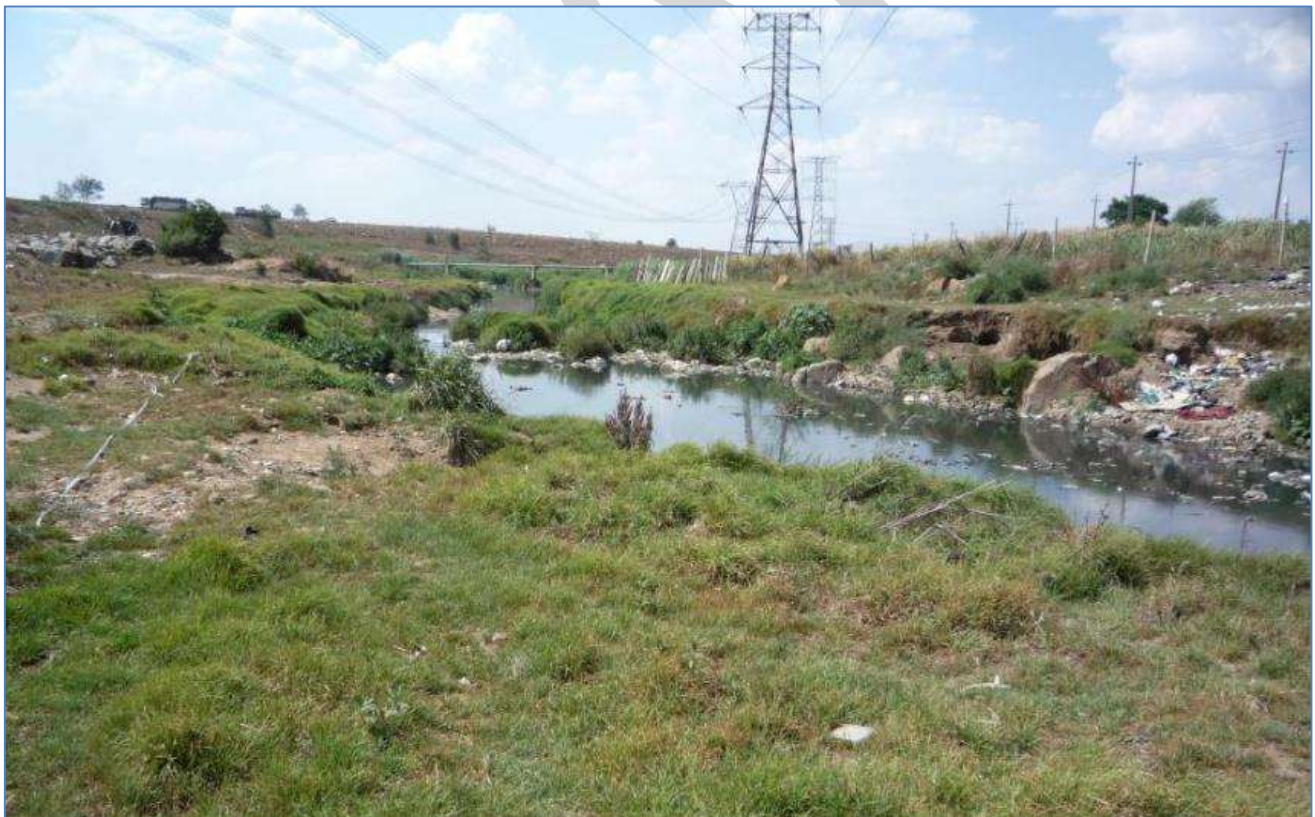
Figure 15, position 2: View north (downstream) of the slow-flowing reach of the Kaalspruit below the rapids, with the embankment of Riverside Road forming the distant horizon. Note the eroded bank, degraded secondary grassland on either side invaded near the watercourse by alien *Pennisetum clandestinum* (kikuyu grass), and the pipeline used as a water bird perch above the river.

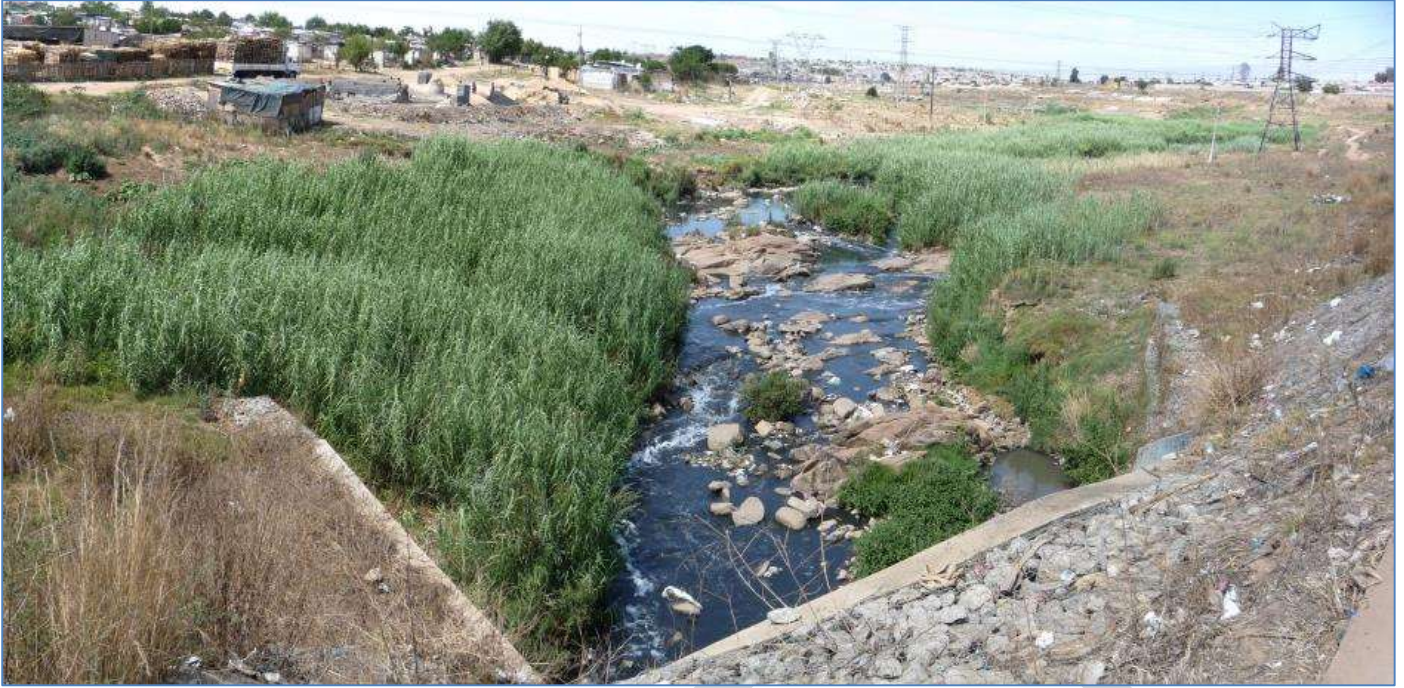
Figure 16, position 3: View south (upstream) from the northern edge of the study area, taken from the bridge crossing Riverside Road. Note the reed-fringed banks of the strong-flowing Kaalspruit over its rocky bed, and the mix of secondary grassland and croplands on the banks with disturbance mostly close to the housing. Note the minimal damming effect of the road embankment due to the deep hard river bed (cf. Fig. 17).

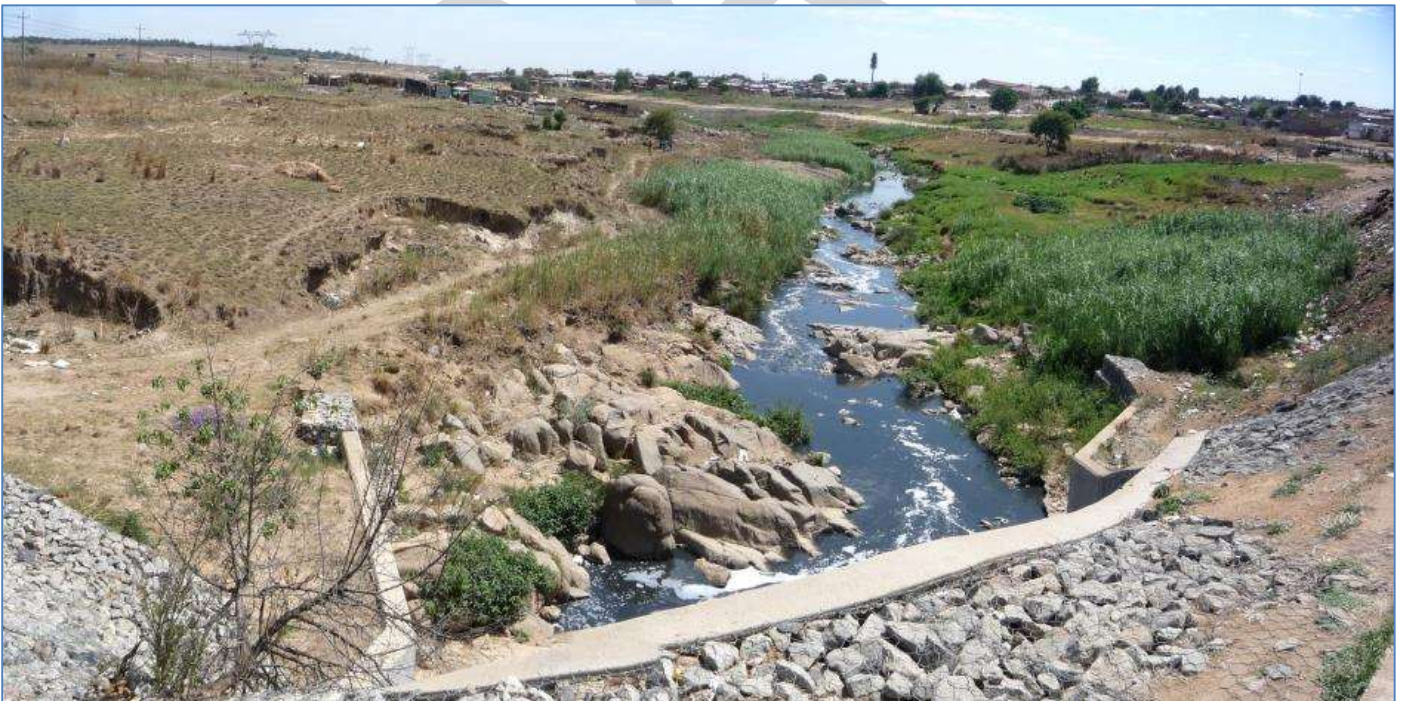
Figure 17, position 3: View north (downstream) of the less developed and more natural habitats along the Kaalspruit below its crossing of Riverside Road. Some newer housing does extend north along the eastern (right) edge of the drainage line, and there is some informal settlement and cropland along the banks, including clearing patches of reeds and excavating the river bed to acquire fertile sedimentary soils.

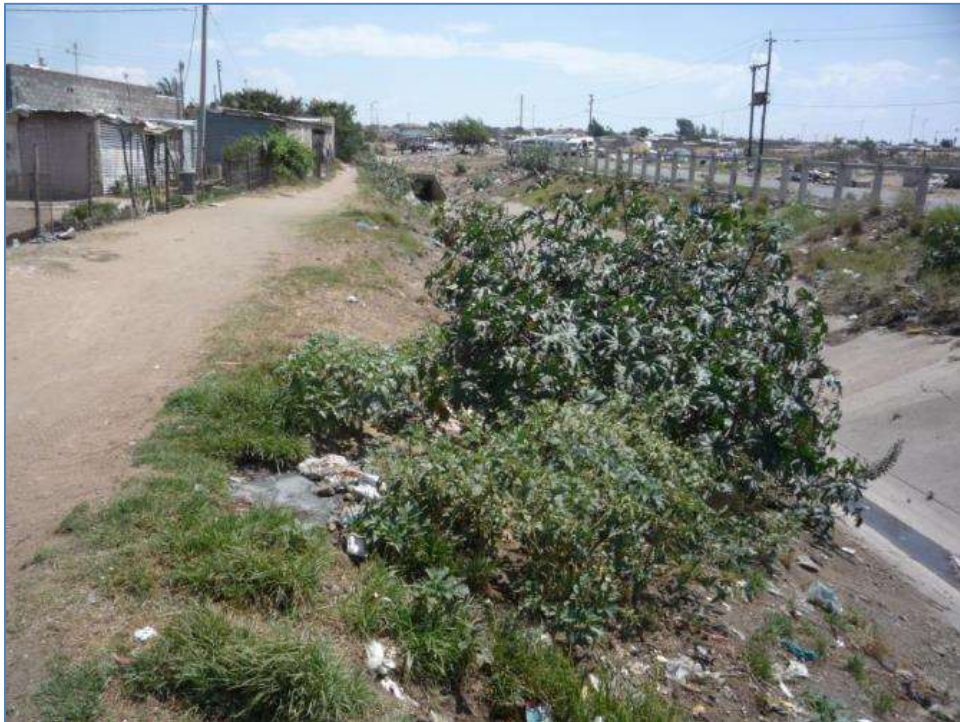
Figure 18, position 4: View south (upstream) along the concrete-lined canal to where the start of the open tributary emerges from a storm-water drain passing under 29<sup>th</sup> September Street, but not as a distinct watercourse. Note the proximity of informal housing to the east (left) edge and tarred road to the east (right).

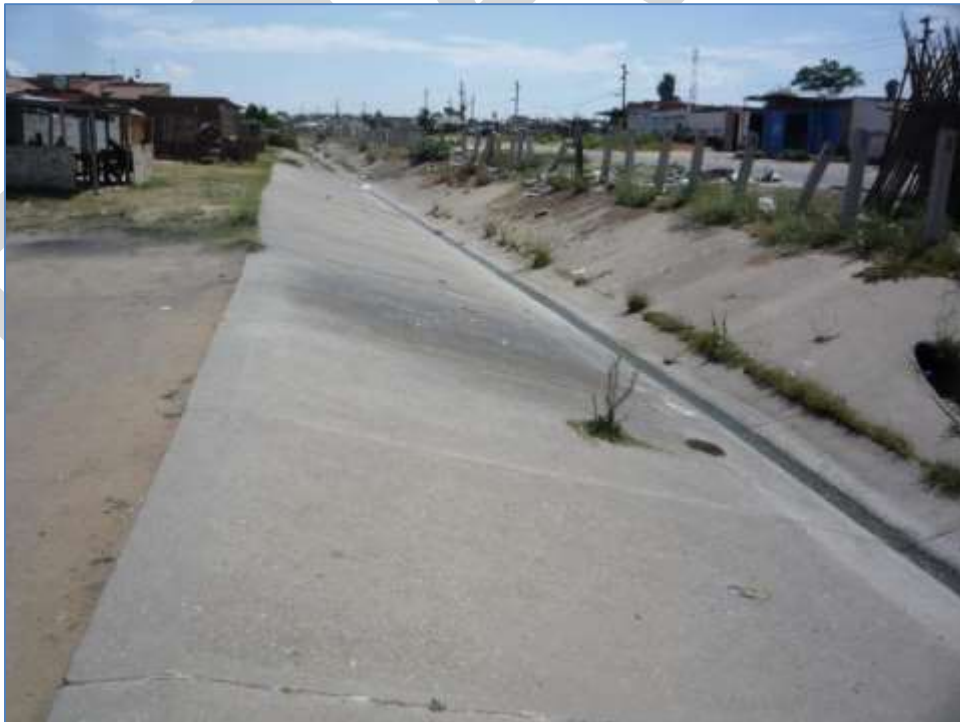
Figure 19, position 5: View south (upstream) from further down the concrete-lined canal than Fig. 18, showing the incursion of temporary shelters, sales areas and litter along the edges. Note the impermeable road surface running alongside the canal and lack of any flow-reduction structures within the relatively steep canal.

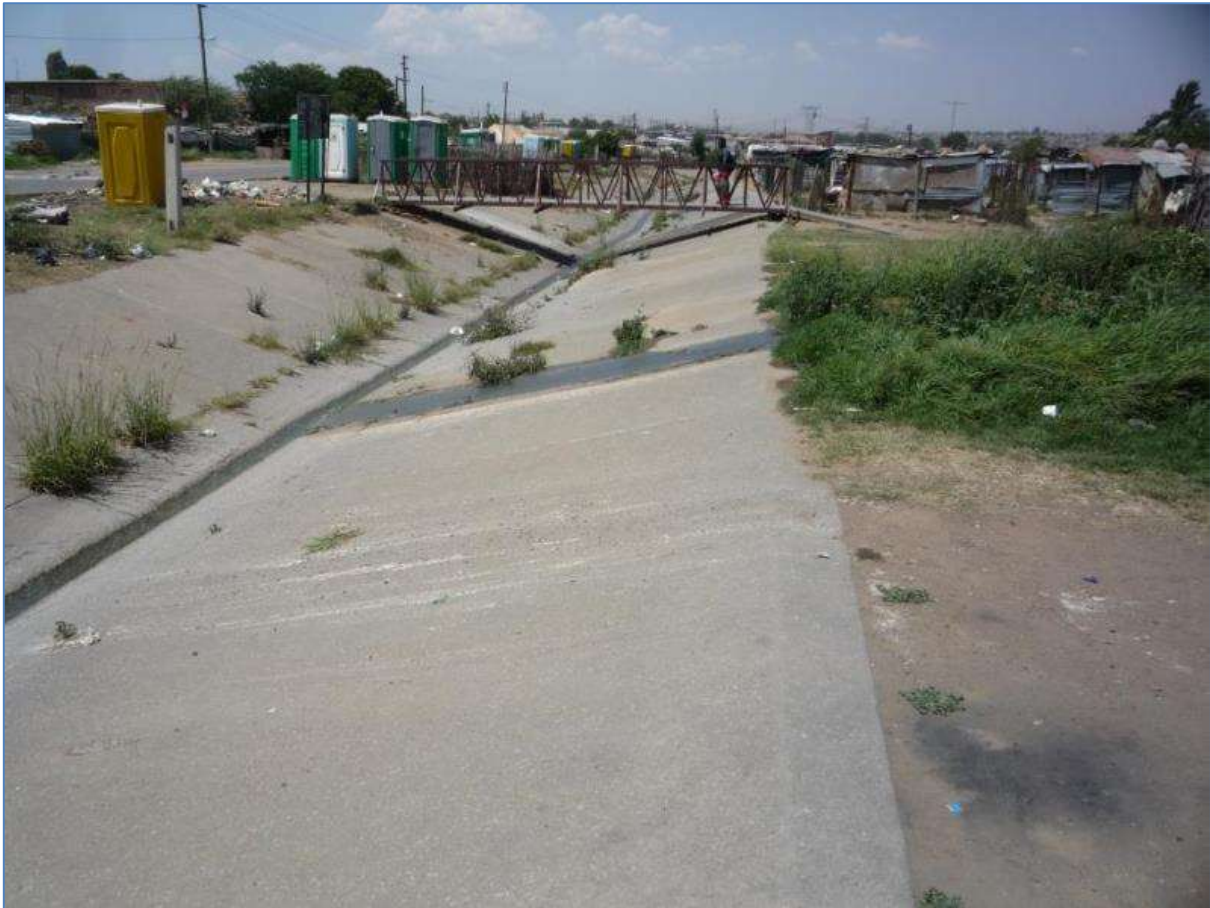
**Figure 20, position 5: View north (downstream) from the same position as Fig. 19, showing weeds growing where runoff/seepage down a side street leaks into the canal, a pedestrian bridge across the canal, informal housing encroaching on the east (right) bank and portable toilets on the west (left) bank. Note the lack of any flow-reduction structures within the canal and its relatively steep gradient.**

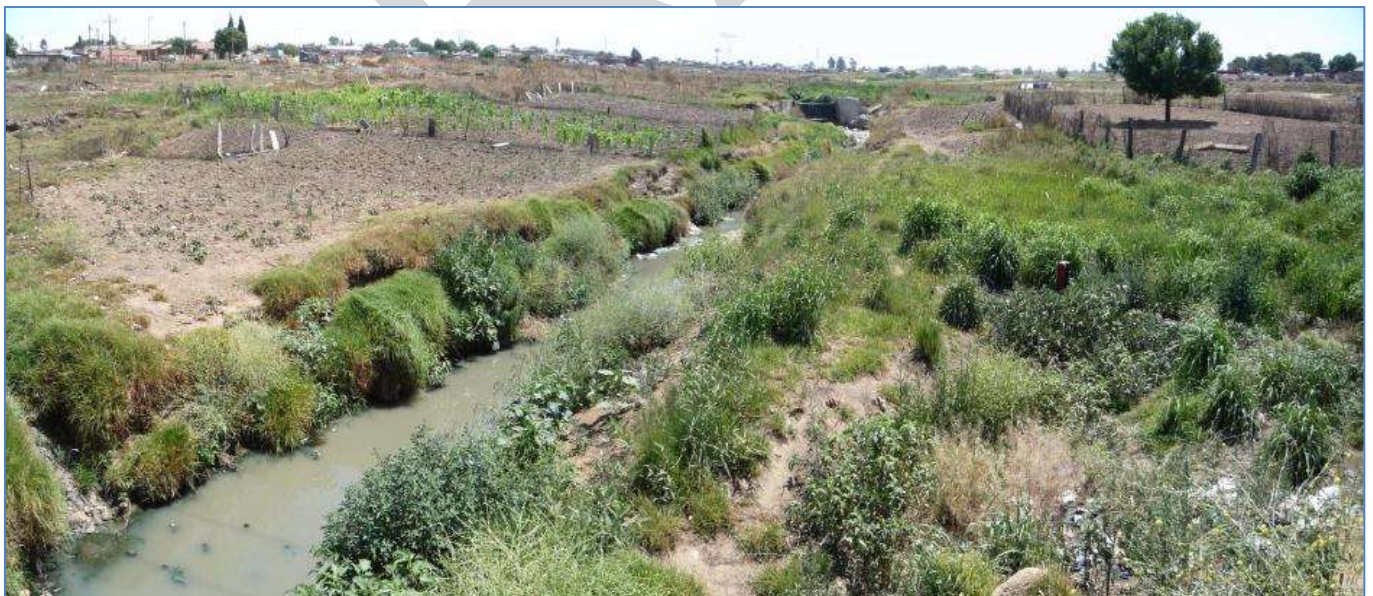
**Figure 21, position 6: View west (upstream) towards where the K1 Tributary emerges from housing into an extensive open area, most of which is under cultivation with little natural vegetation and many weeds in between and along the banks. A weir above the open water breaks the flow, but further upstream deep erosion of the drainage line is evident, apparently where water emerges at high velocity from the upper concrete-lined canal.**

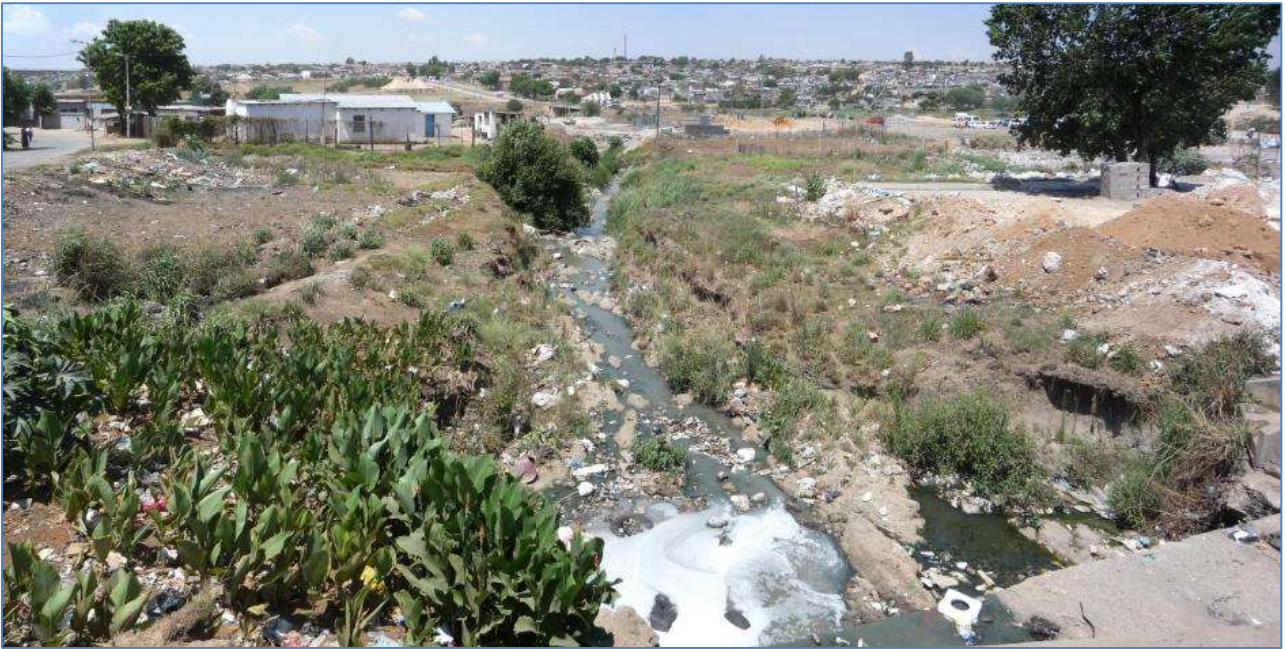
Figure 22, position 6: View northeast (downstream) towards where the K1 Tributary passes under Karee Street *en route* to the Kaalspruit mainstem in the valley below. Note the drainage line invaded by alien ornamental cannas to the west (left), constricted by levelling for a concrete-block-making enterprise and covered with froth. Little natural vegetation remains and most trees are introduced alien species. See Fig. 12 for where the K1 Tributary actually enters the Kaalspruit.

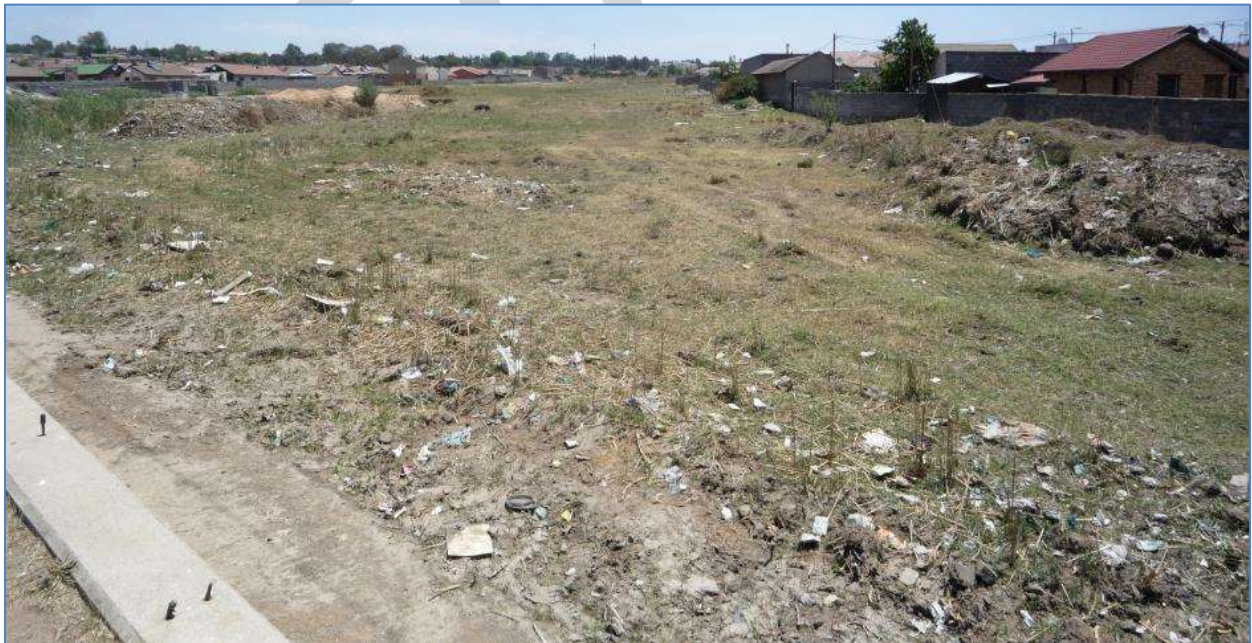
Figure 23, position 7: View west (uphill) from where Finger Fish Street crosses the upper reaches of the K2 Tributary, at the time a strip of dry degraded grassland between the housing, encroached along the edge by dumping of rubble, with the only wetland entering from the south (left) where seepage/runoff from the housing support a drainage line with *Typha* bulrushes and some sedges. Residents report that during heavy rains runoff from the grassland floods across the road.

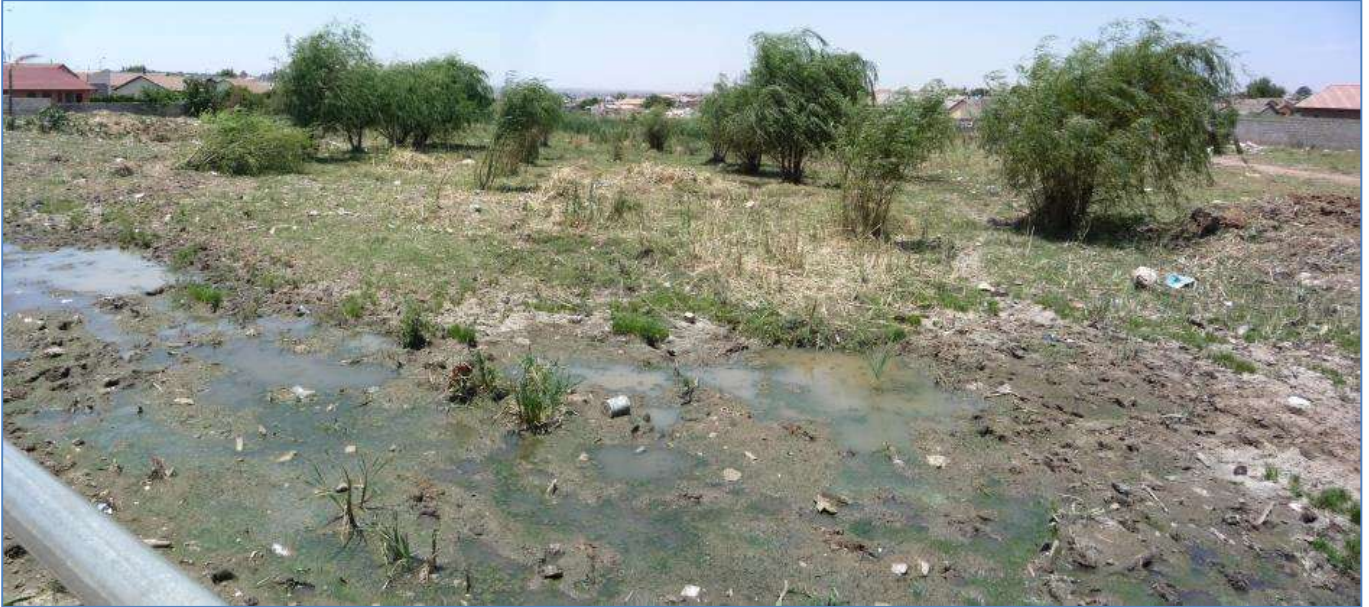
Figure 24, position 7: View east (downstream) from the same position as Fig. 23, showing the dry watercourse of the upper K2 Tributary (apart from seepage under Finger Fish Street from township seepage on the other side), with alien *Salix* willow trees in the foreground and extensive bulrush beds in the background that indicate the flatter more fertile conditions downstream.

Alien woody species such as *Eucalyptus* sp (Fig. 41) and *Salix babylonica* (Fig. 24) are found at some localities, while the indigenous *Vachellia karroo* may be locally present.

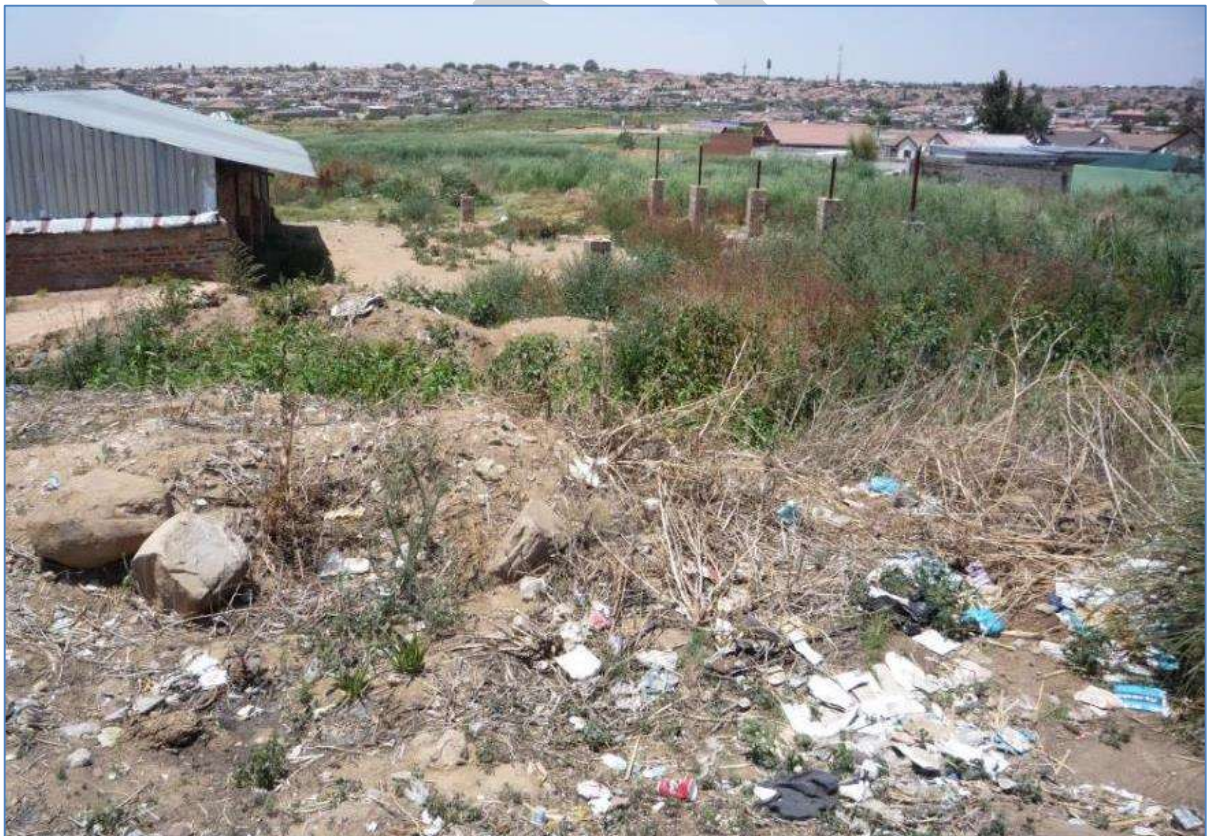
Figure 25, position 8 (&13): View south from Angelfish Street, looking down the drainage line of K2b Tributary to its junction within a large crow's foot of bulrush beds and towards the confluence of the K2, K2a and K2b Tributaries (cf. Fig. 3). The bare area created within the bulrush beds is part of a specially created and equipped recreation site, with the central K2 Tributary passing just to the near (north) side of the recreation site. Note the structures built into the riparian zone.

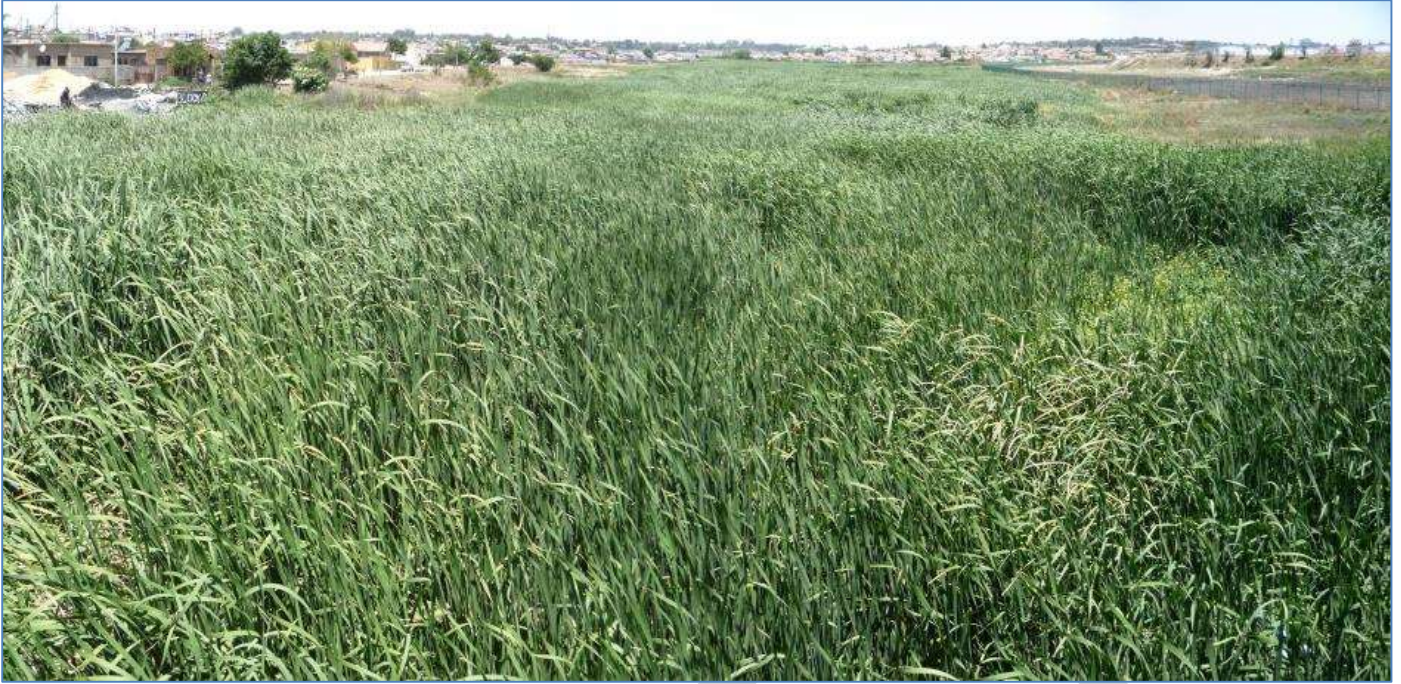
**Figure 26, position 8: View west (upstream) from K2 Tributary's crossing under Archer Fish Street, looking along the 'hind-toe' of the crow's foot and K2 Tributary's wide bed of bulrushes. Housing and dumping intrude on the west (left) bank but on the east (right) bank a long high fence around commercial developments reduces disturbance to only a few small cultivated plots along its outer edge and leaves some secondary grassland.**

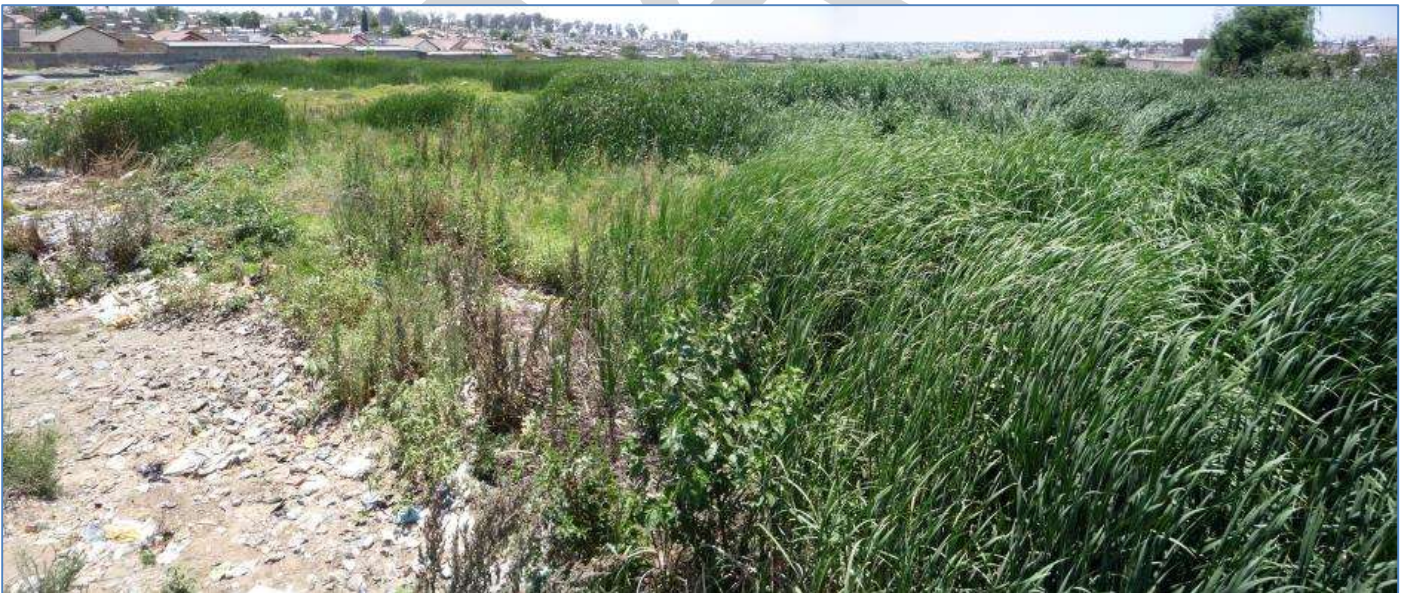
**Figure 27, position 8: View east (downstream) along the K2 Tributary taken below its crossing under Archer Fish Street, showing where the drainage of runoff from the impermeable road surface has eroded and opened the outside of the bend, reducing the bulrush beds as their soils are washed away, with the streambed quality declining and giving way to reeds further downstream in the distance.**

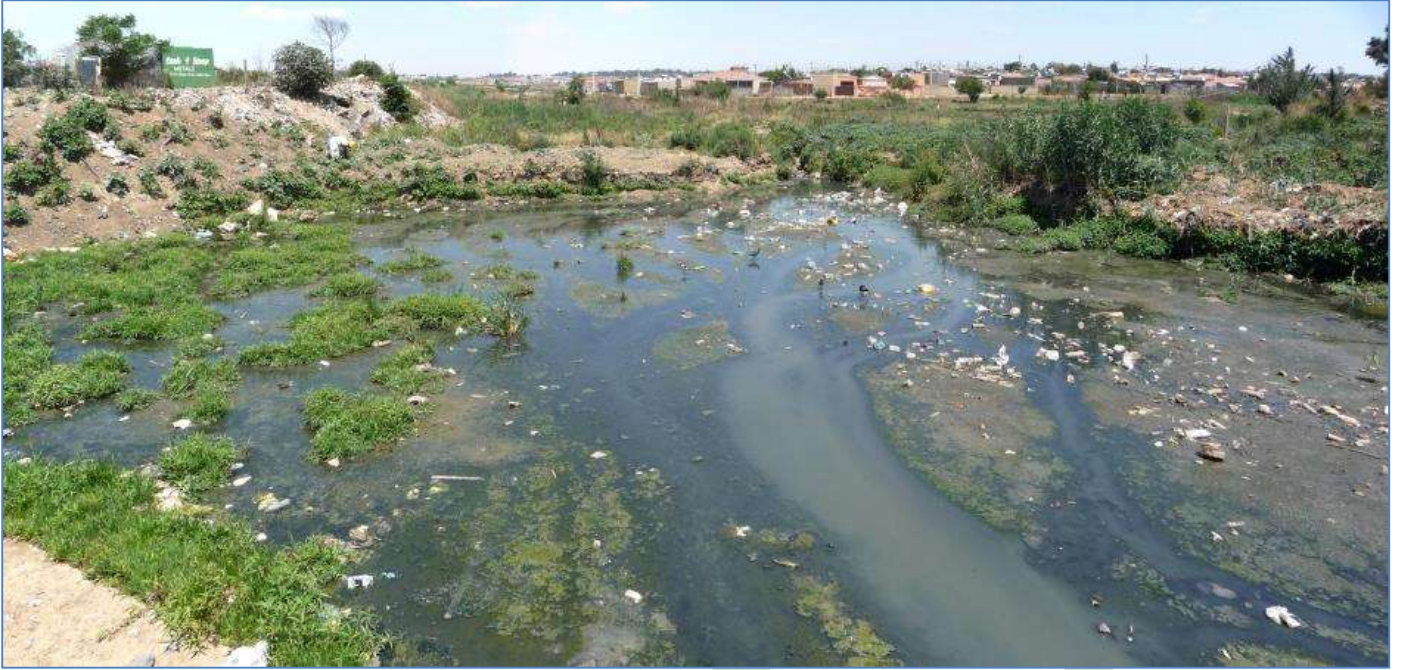
**Figure 28, position 9: View west (upstream) from where Glassnose Street crosses and dams up the K2 Tributary. Note the intrusions of landfills and cultivation on the edges of the watercourse, but the presence of Glossy Ibis and other smaller wetland birds feeding amongst the litter in the sludge and sediment.**

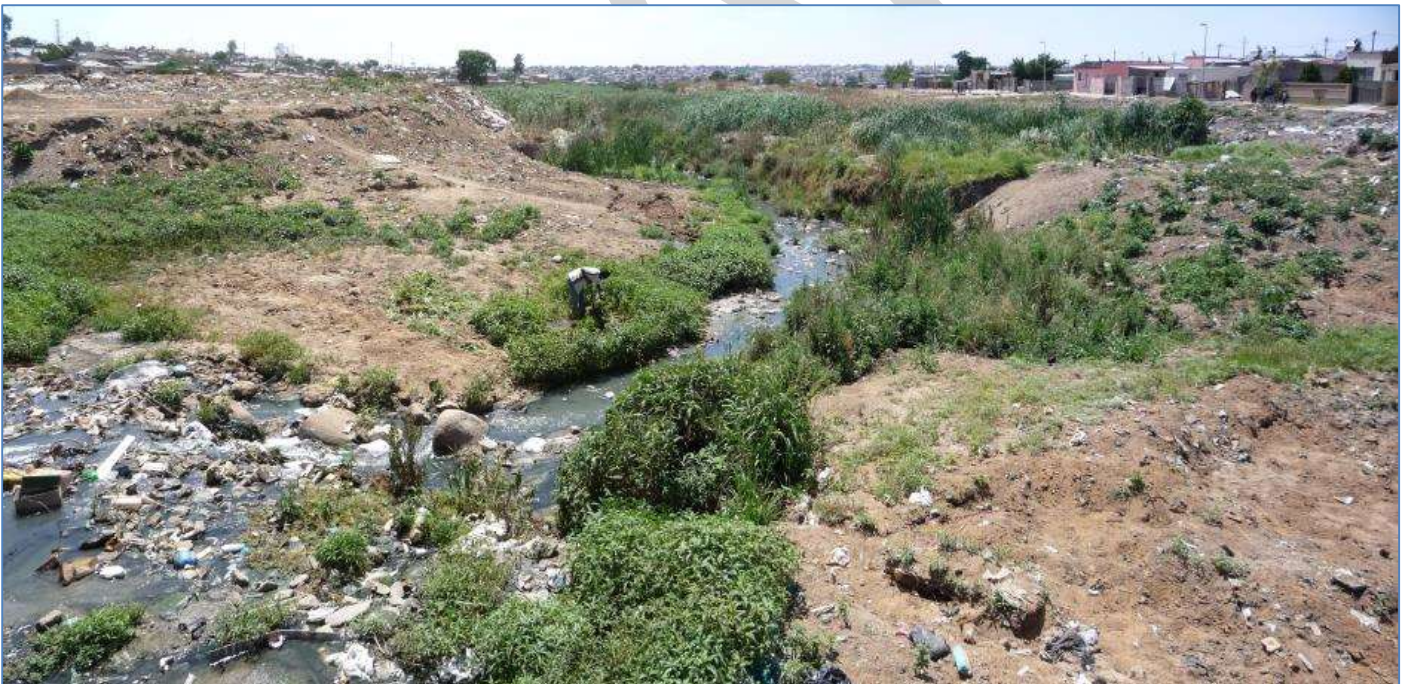
**Figure 29, position 9: View east (downstream) where the K2 Tributary flows out from under the Glassnose Street crossing and constriction. Note the eroded bed and banks, and the degraded and transformed edges of the watercourse between the housing, with minimal marginal vegetation to protect and retain them.**

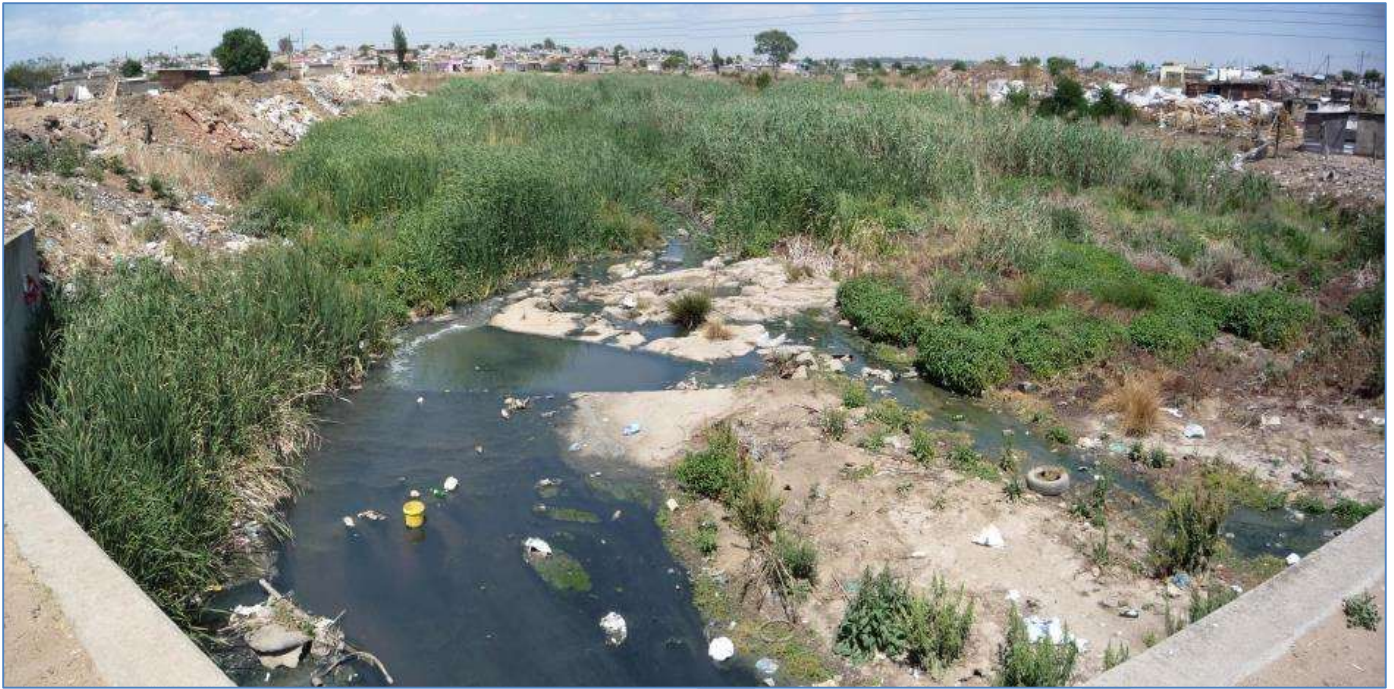
**Figure 30, position 10: View west (upstream) where the lower reaches of the K2 Tributary pass under Republic (Main) Road. Note the encroachment of landfills and informal housing along the banks, the presence of some reed beds to stem water flow, and the obvious litter load.**
