# The proposed Kaalspruit Open Space Project, Thembisa, Gauteng

## Kaalspruit River Rehabilitation

### Biodiversity Scan: Vegetation and vertebrate report

# AN ASSESSMENT OF THE FLORA, HABITATS AND VERTEBRATE FAUNA EXPECTED ALONG THE PROPOSED KAALSPRUIT WATERCOURSE REHABILITATION IN TEMBISA, JOHANNESBURG

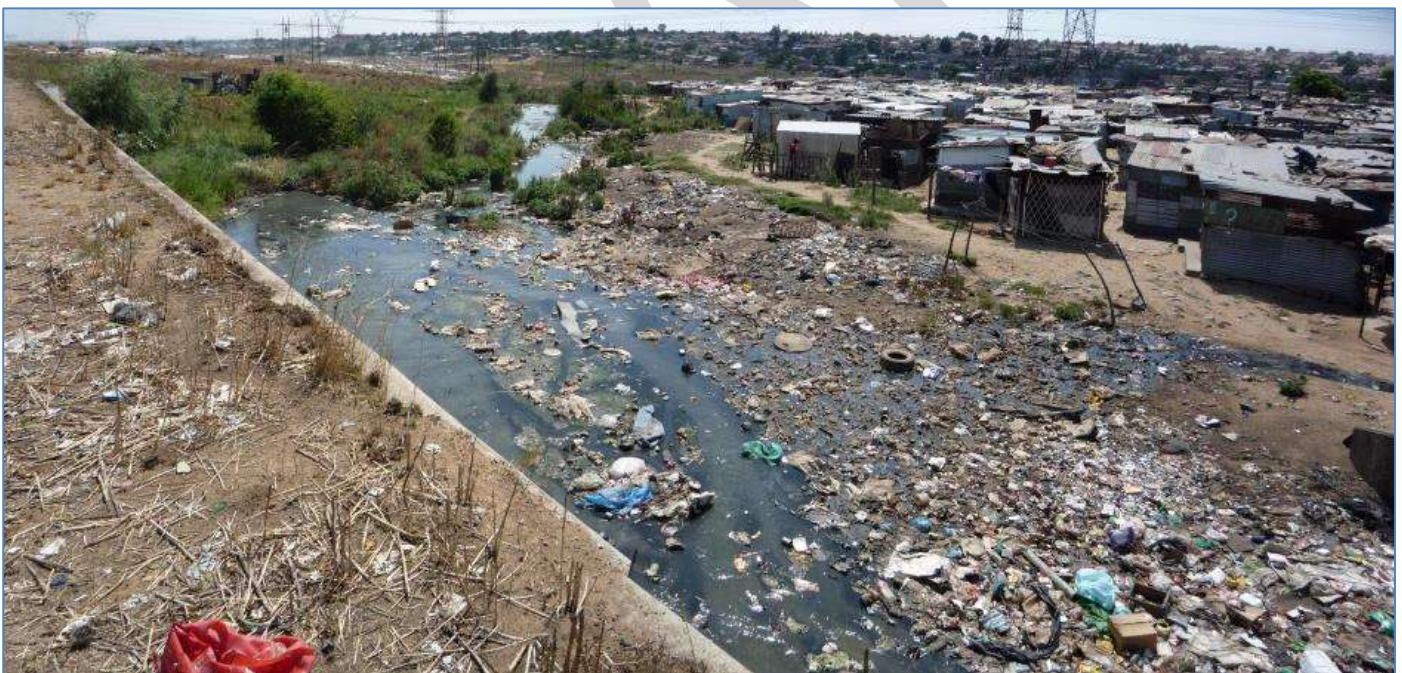
**Figure 31, position 10: View east (downstream) towards where the K2 Tributary joins the northern section of the Kaalspruit mainstem in the valley floor below. Note the eroded river bed, total incursion of informal settlements and their waste on the south (right) bank, but the semi-natural though degraded vegetation on the north (left) bank.**

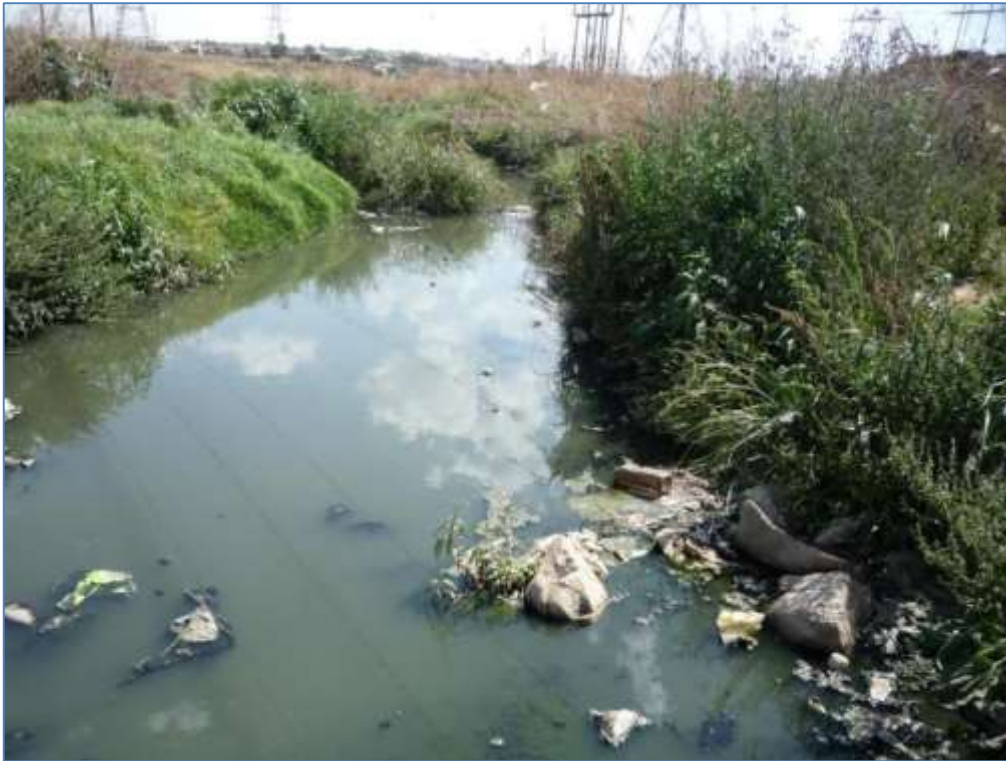
**Figure 32, position 2(& 10): View southwest (upstream) from where a concrete causeway crosses and dams up the K2 Tributary, almost at its confluence with the Kaalspruit mainstem. Note the narrow deep bed at this point, with its rim of mainly alien plants and weeds, and the ever-present litter.**

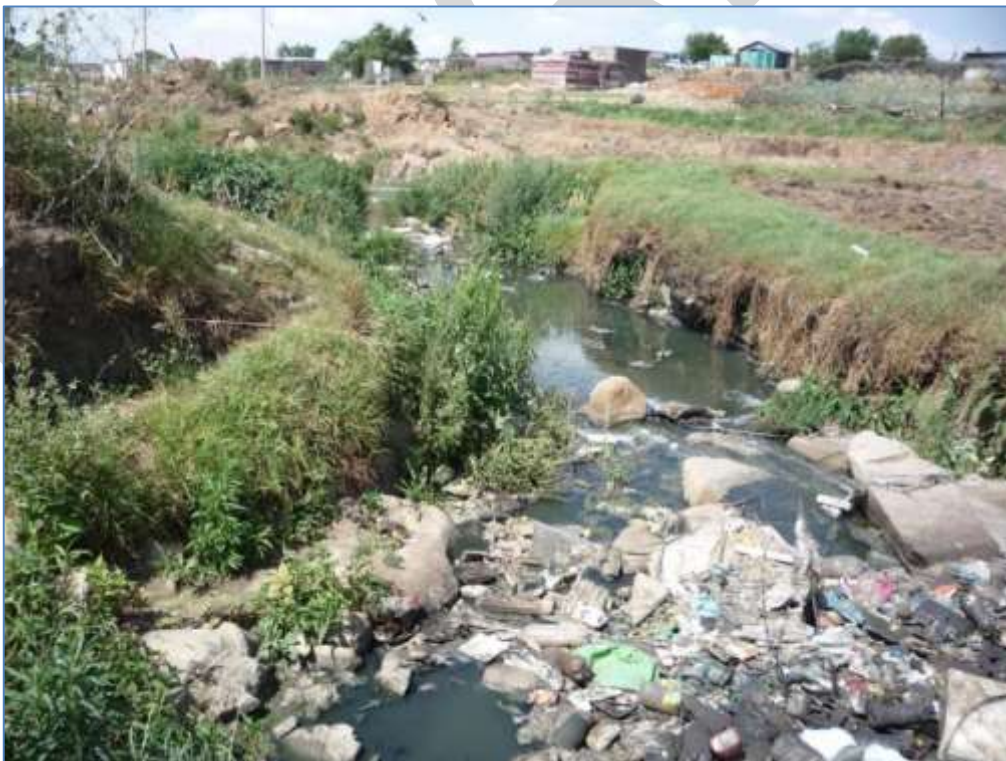
**Figure 33, position 2 (& 10). View northeast (downstream) at the K2 Tributary's confluence with the nearby Kaalspruit mainstem down below in its deep bed. Note the disturbed and eroded stream bed below the causeway obstruction, and the croplands extending right to the confluence.**

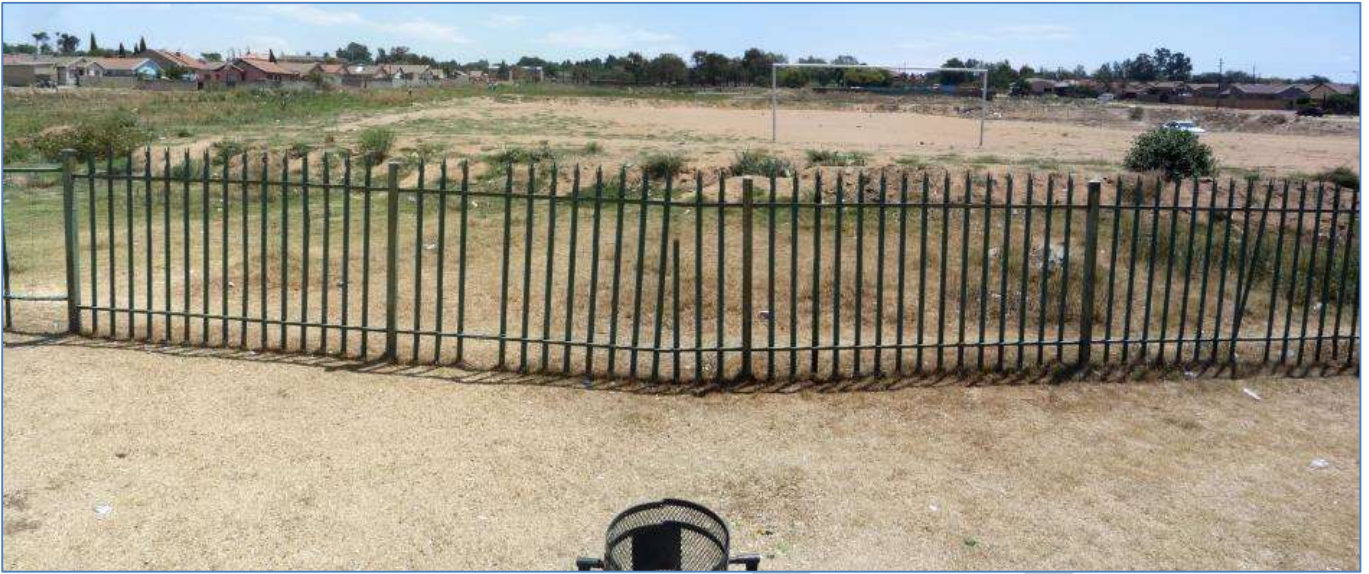
Figure 34, position 11: View southwest (uphill), looking towards the distant trees within the President Park Agricultural Holding catchment for the K2a Tributary, with a soccer field and fenced playground built up on landfills obstructing the north (right) side of the drainage line. At the time, the drainage line between the housing on either side was dry, degraded indigenous grassland, but with signs of erosion by seasonal flows.

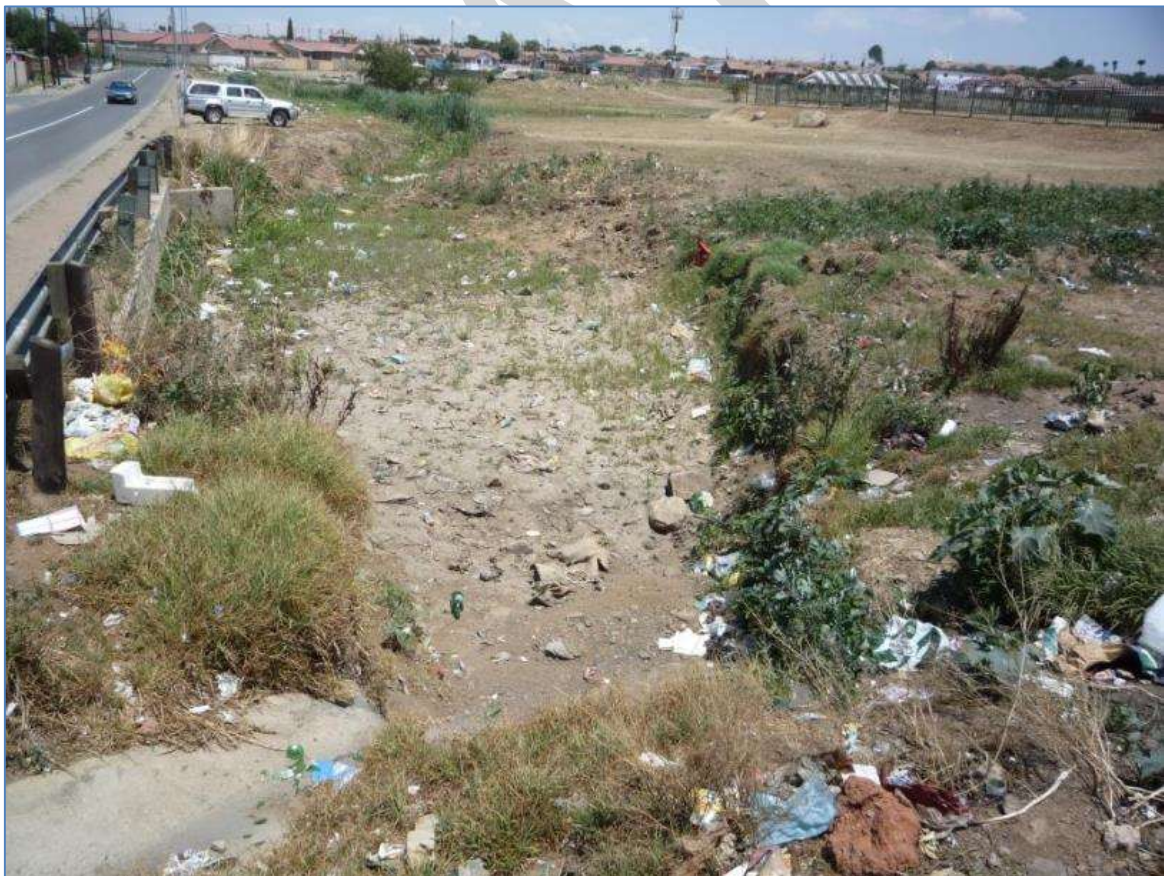
Figure 35, position 11: View along the west side of Camellia Street, showing where the drainage line of the K2a Tributary passes round the end of a landfill for a fenced recreation area and then re-enters its bed under the street. The narrow strip of green bulrushes that remains in the bed is fed by drainage of seepage/runoff from housing to the east (far side) of the tributary.

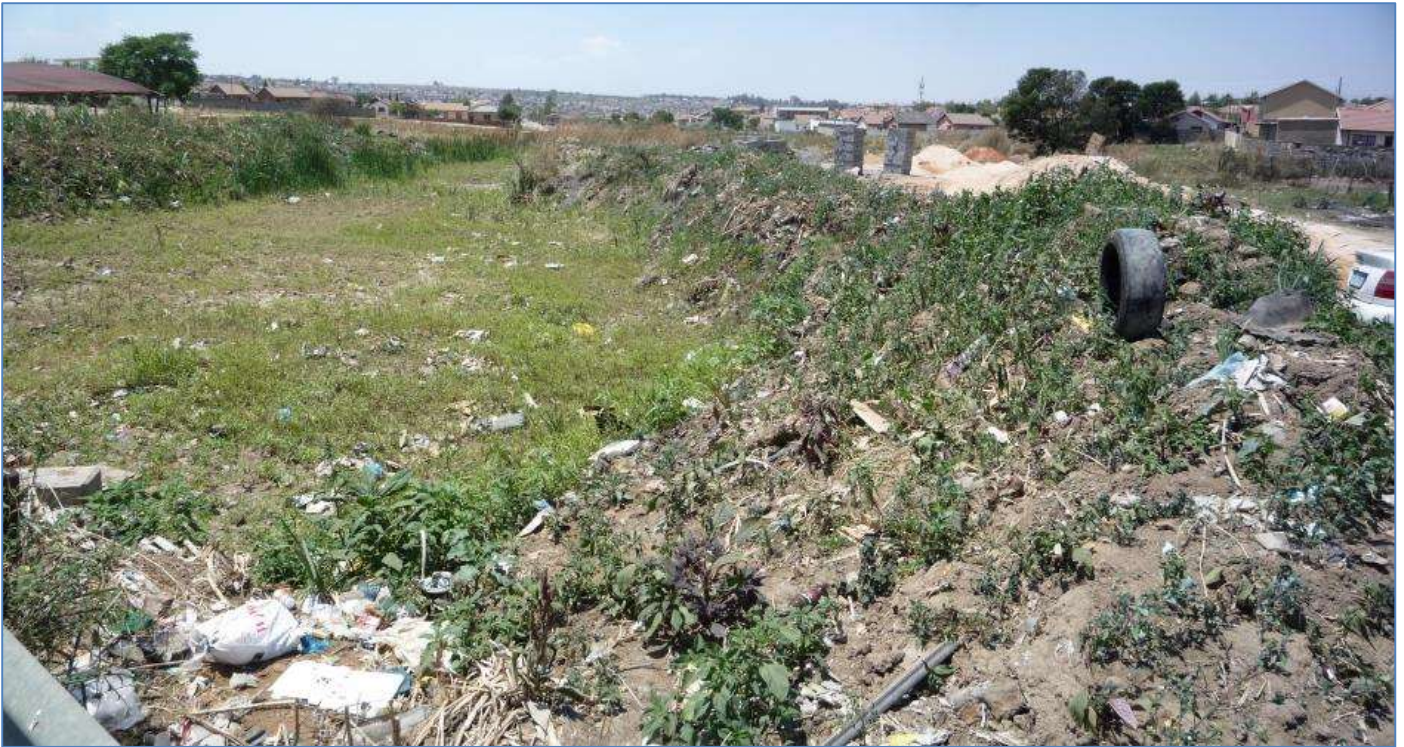
Figure 36, position 11: View northeast along the K2a Tributary below where it crosses Camellia Street, showing the narrowed and channeled drainage line with earth berms on either side, sited some distance from the nearest housing and presumably to protect it from flooding. Note the highly degraded secondary vegetation that has appeared, much of it alien species.

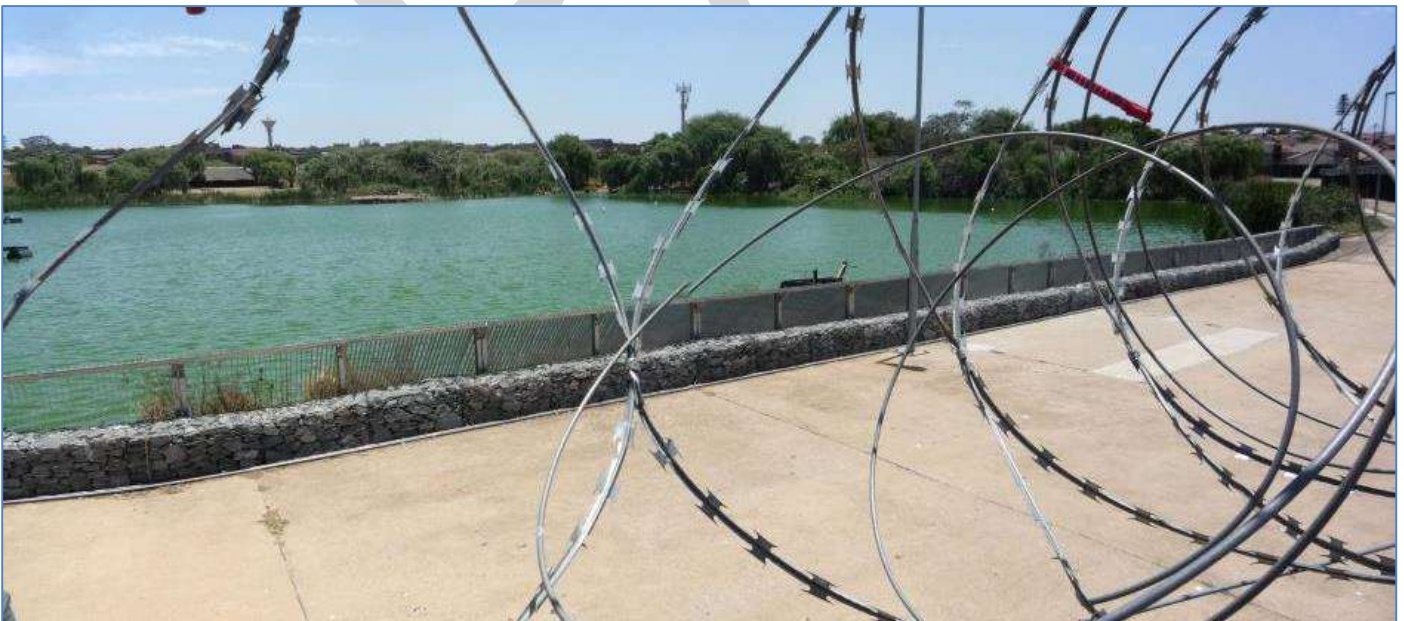
Figure 37, position 12: View north along the wall of the large dam within the heavily fenced Eskom property that forms the border of the site at this point and controls the catchment flow into the K2b Tributary. At the time, this large body of water, fringed by large trees, supported a large heronry and attracted some fish-eating cormorants and gulls.

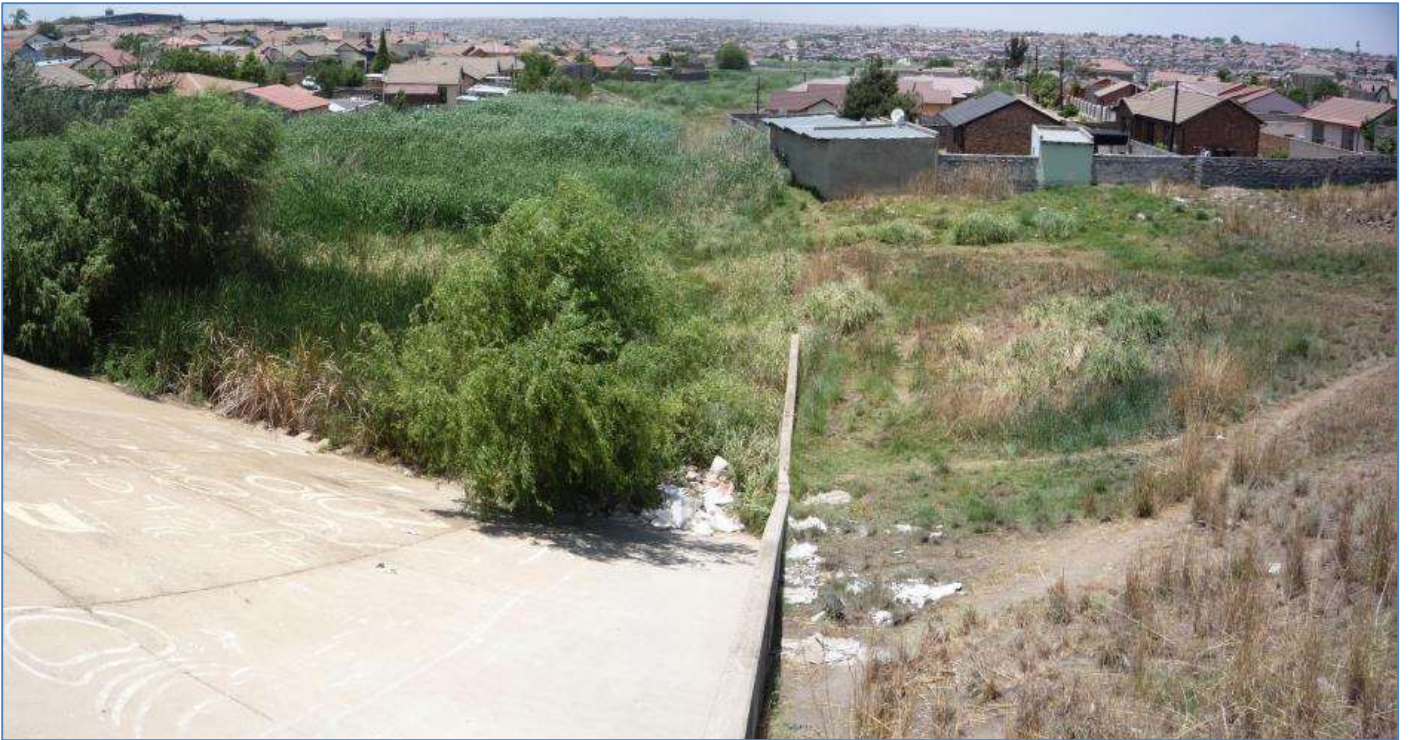
**Figure 38, position 12: View southeast along the bulrush-filled drainage line of the K2b Tributary, almost completely encroached by the housing on either side, but still with cultivation on what remains of the natural grassland on the west (right) bank. The concrete spillway below the dam in Fig. 37 supports a few willow trees, probably from cuttings/branches washed into its base.**

The moist wetland system covers large parts of K2 including K2b, but excludes the upper parts of K2a and K2c (Figure 3). This system is predominantly covered with indigenous bulrushes (*Typha capensis*). This wetland system is illustrated by Figs. 25, 26, 27, 28, 30 and 46. By far the largest part of this wetland system is covered by the totally dominant *Typha capensis*, but reeds (*Phragmites australis*) may also be locally prominent, while very few other species are present (Fig. 26). At somewhat more open spaces, such species occur as *Cortaderia selloana* (Figs. 39 & 40) *Persicaria lapathifolia*, *Persicaria serrulata*, *Mirabilis jalapa*, *Canna indica*, *Rumex crispus*, *Verbena bonariensis*, *Conyza bonariensis*, *Plantago lanceolata*, *Pennisetum clandestinum*, *Salix babylonica* (Figs. 38 & 39) and *Morus alba*.

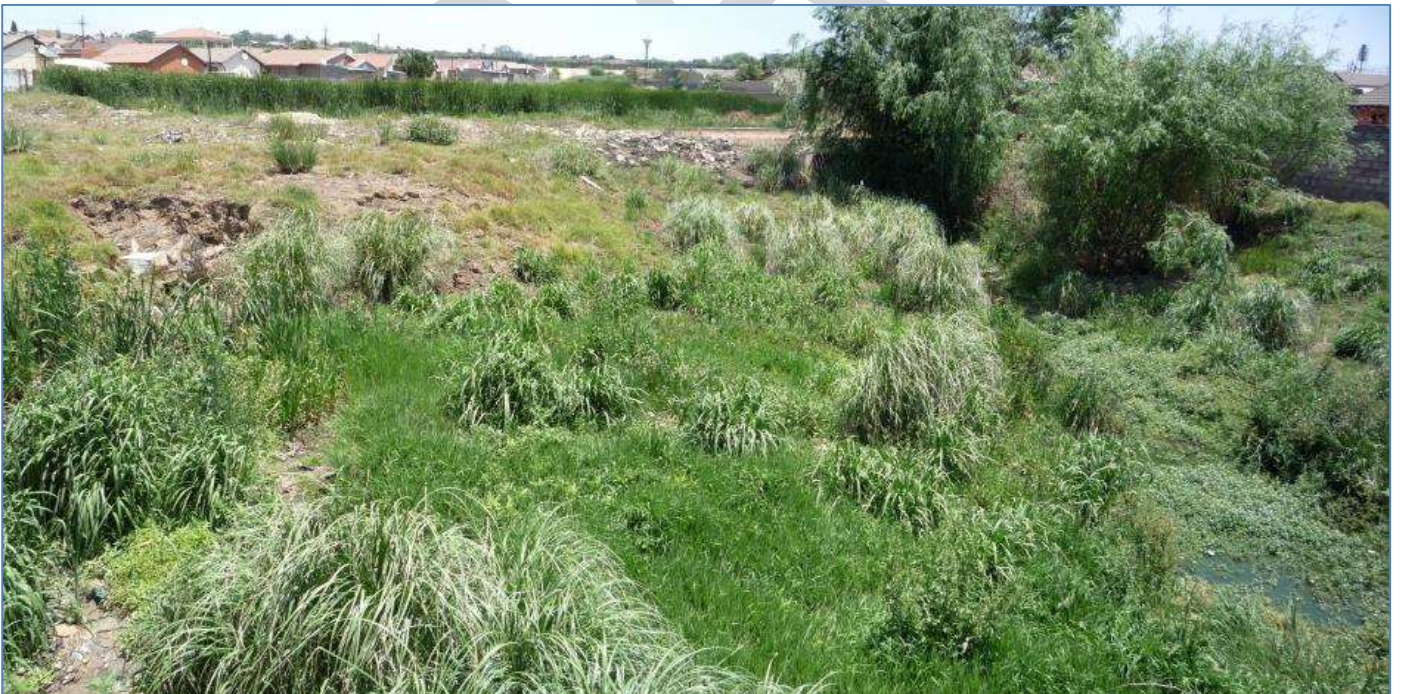
**Figure 39, position 13: View northwest (upstream) from where the K2b Tributary crosses Angelfish Street. Upstream, another dirt road with a culvert forms a wall across the tributary, resulting in a bulrush-filled dam above and an eroded bank but grassy stream bed below, presumably maintained by seepage from the dam and attracting Sacred Ibis to feed. Willow trees have established on the embankment wall and clumps of pampas grass within the spillway below**

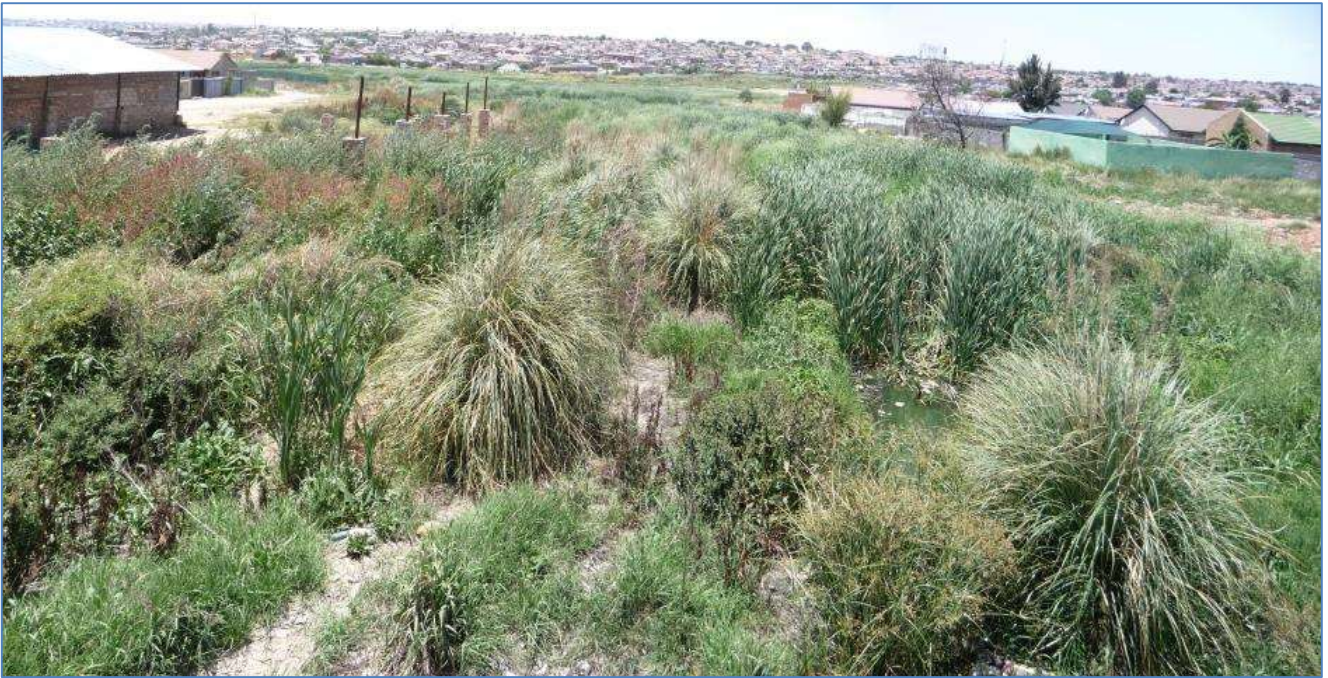
**Figure 40, position 13: View southeast (downstream) along the drainage line of the K2b Tributary, with signs of flood damage in the rocky bed, only clumps of resistant pampas grass and bulrushes remaining, and encroachment by housing on either side before the bed emerges into the wide bulrush-filled crow's foot of the K2, K2a and K2b Tributary's confluence (cf. Fig. 25).**

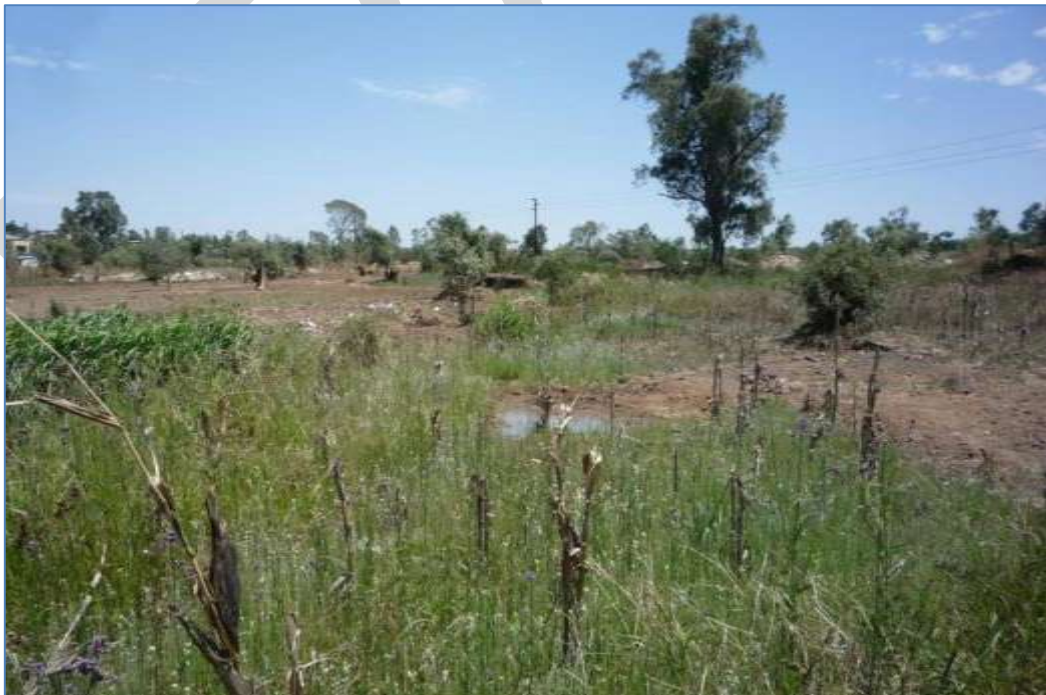
**Figure 41, position 14: View north (uphill) across the large vacant area at the head of the K2c Tributary. A narrow seepage line enters at this point but its origins outside the study area were not traced. The cultivated area and the remaining large alien eucalypts mark the edge of the study area. The ridge beyond supports extensive natural grassland, which, over its brow, leads to the Glen Austin Pan Bird Sanctuary and an adjacent pan (cf. Fig. 1).**

Alien woody species such as *Eucalyptus* sp (Fig. 41) and *Salix babylonica* (Fig. 24) are found at some localities, while the indigenous *Vachellia karroo* may be locally present.

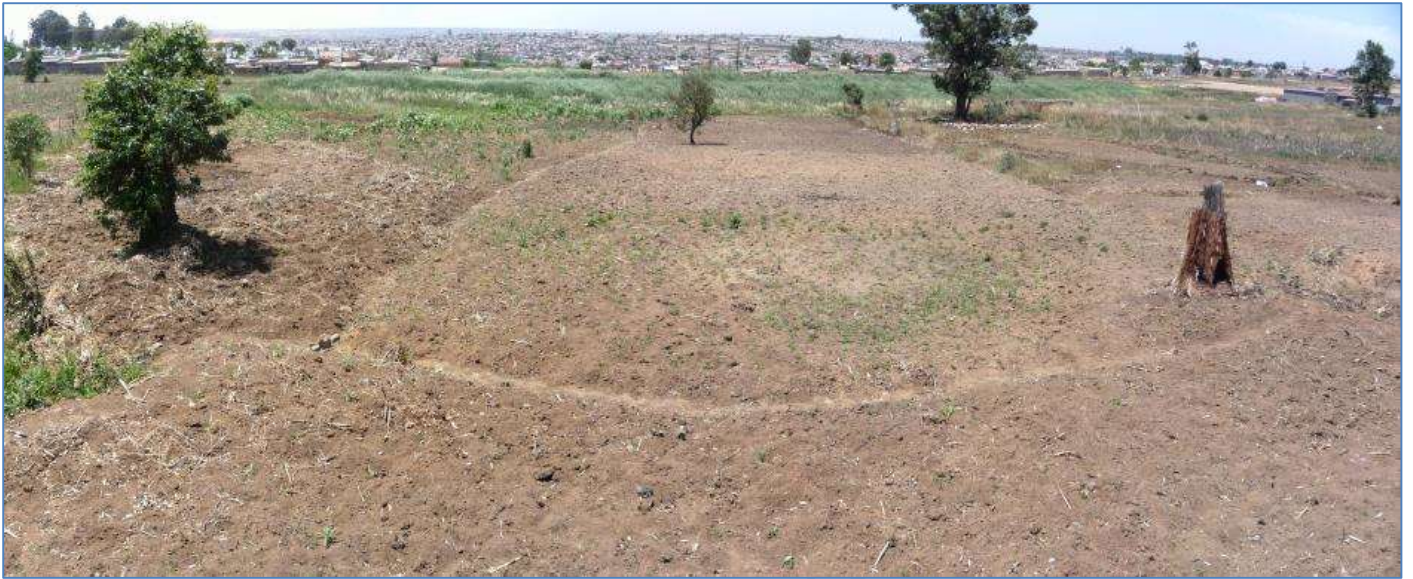
**Figure 42, position 14: View south from the northwest edge of the study area, looking over the open cultivated area at the head of the K2c Tributary to where a wide dam holds the seepage that runs in along the northeast (left) side and the runoff from other small drainage lines crossing the croplands.**

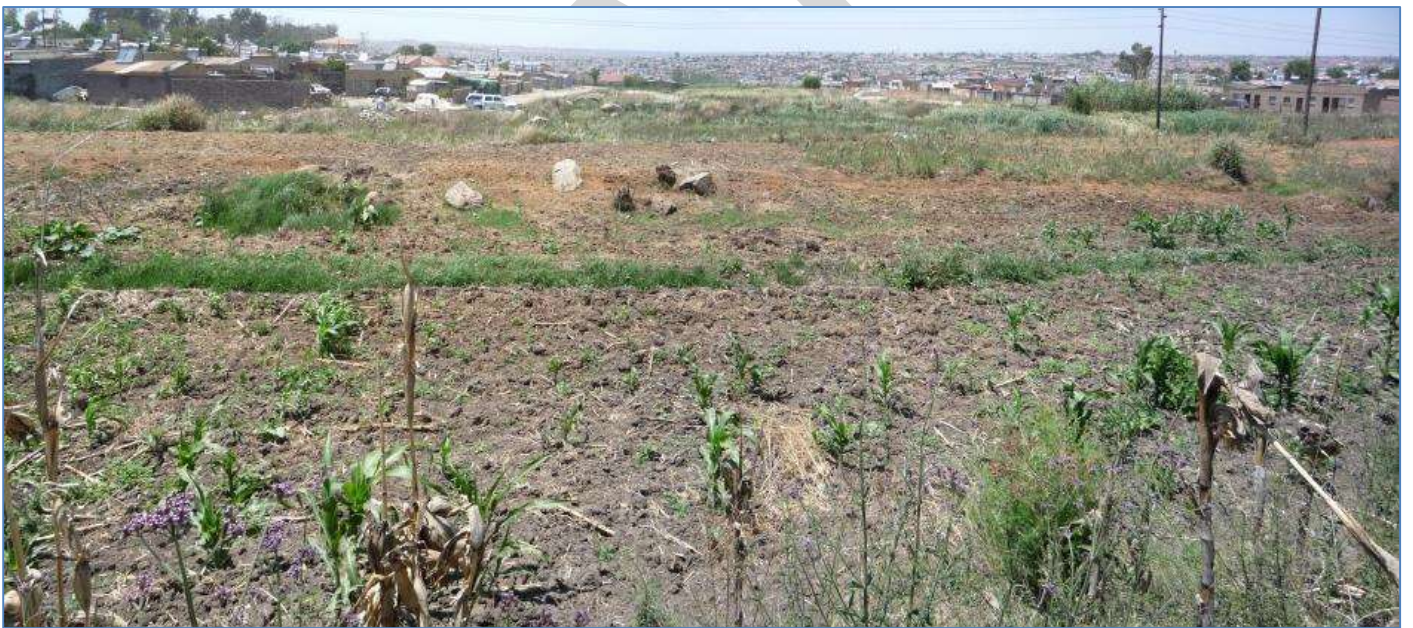
**Figure 43, position 14: View south from below the dam wall in Fig. 42, looking over more cultivated land at the head of the K2c Tributary to where it enters the drainage line between the housing on either side.**

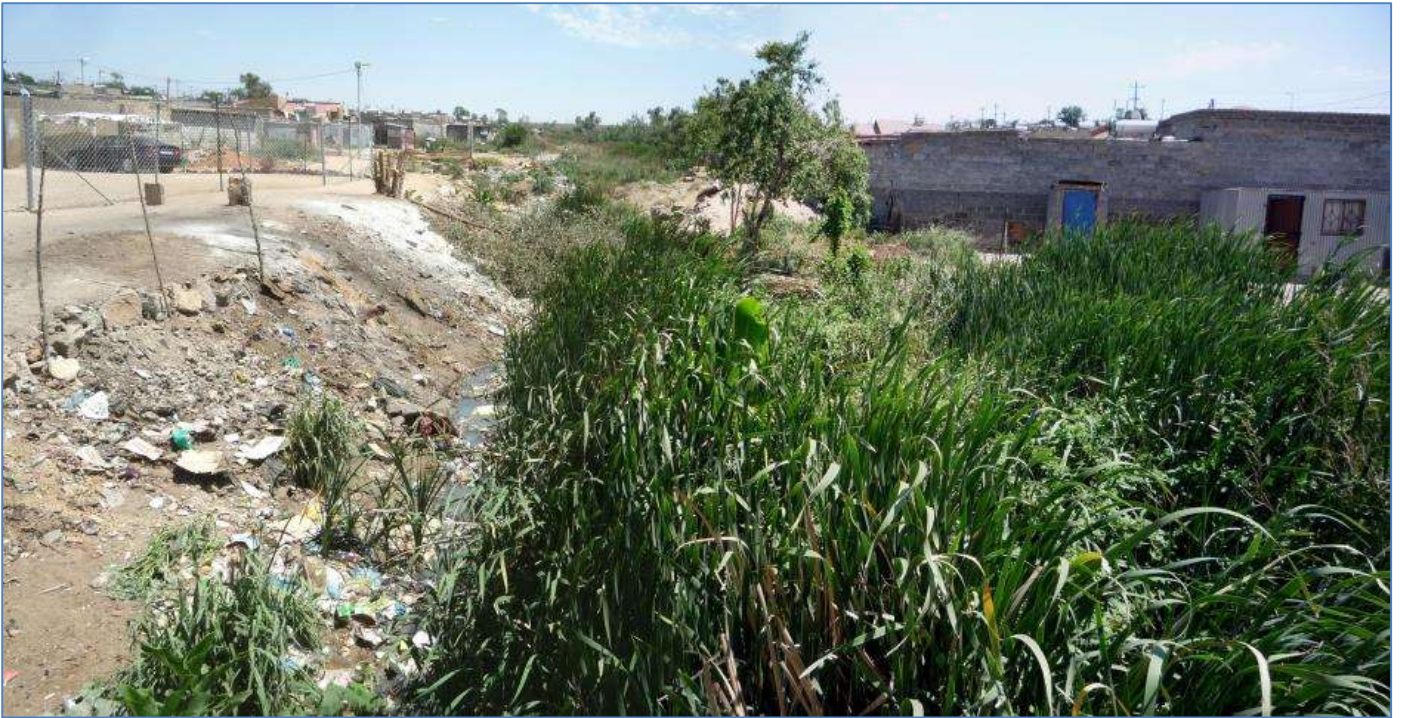
**Figure 44, position 15: View north (upstream) from where Trout Street comes to the eastern edge of the steep, narrow drainage line of K2c Tributary, showing how roads and houses have constricted the watercourse from the east (right) and deliberate landfill from the west (left), yet bulrushes and some indigenous grasses and sedges survive within the stream bed.**

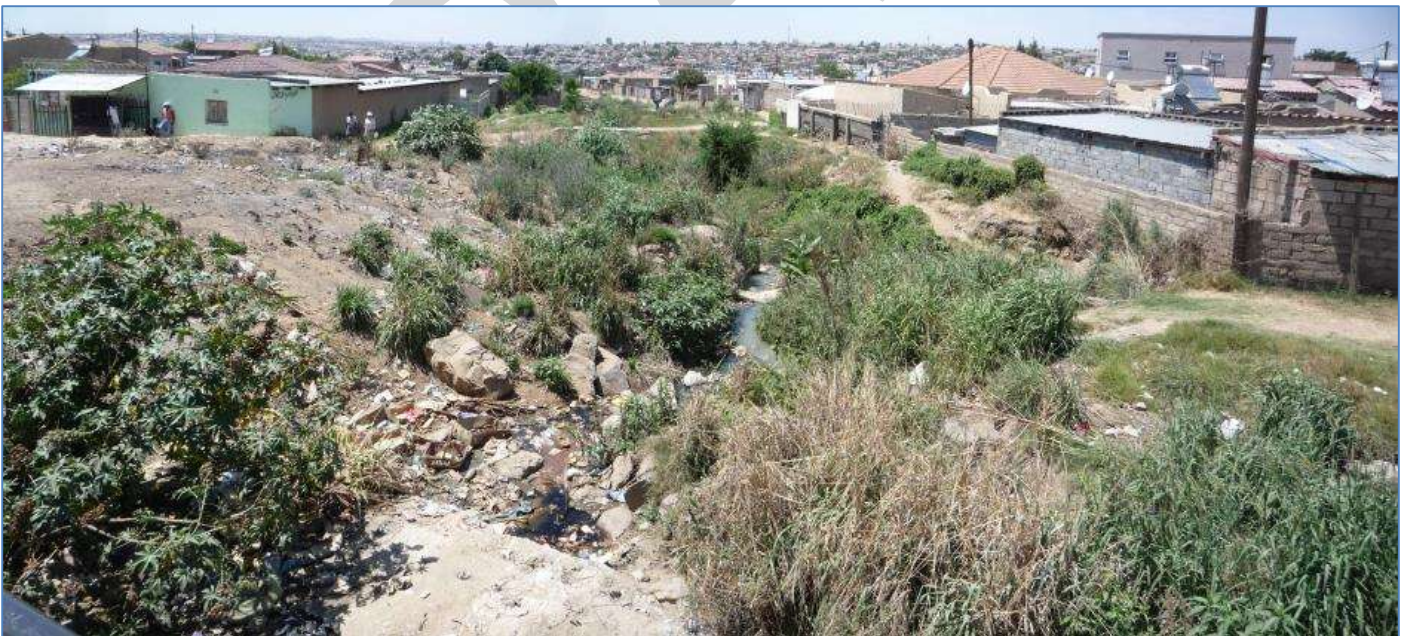
**Figure 45, position 15: View south (downstream) from where Trout Street reaches the east (left) side of the drainage line of the K2c Tributary, constricted by landfill to the east and expanded housing to the west (right). Water still flows in the narrow bed and under an informal roadway, and bulrushes and other alien vegetation survive along its margins.**

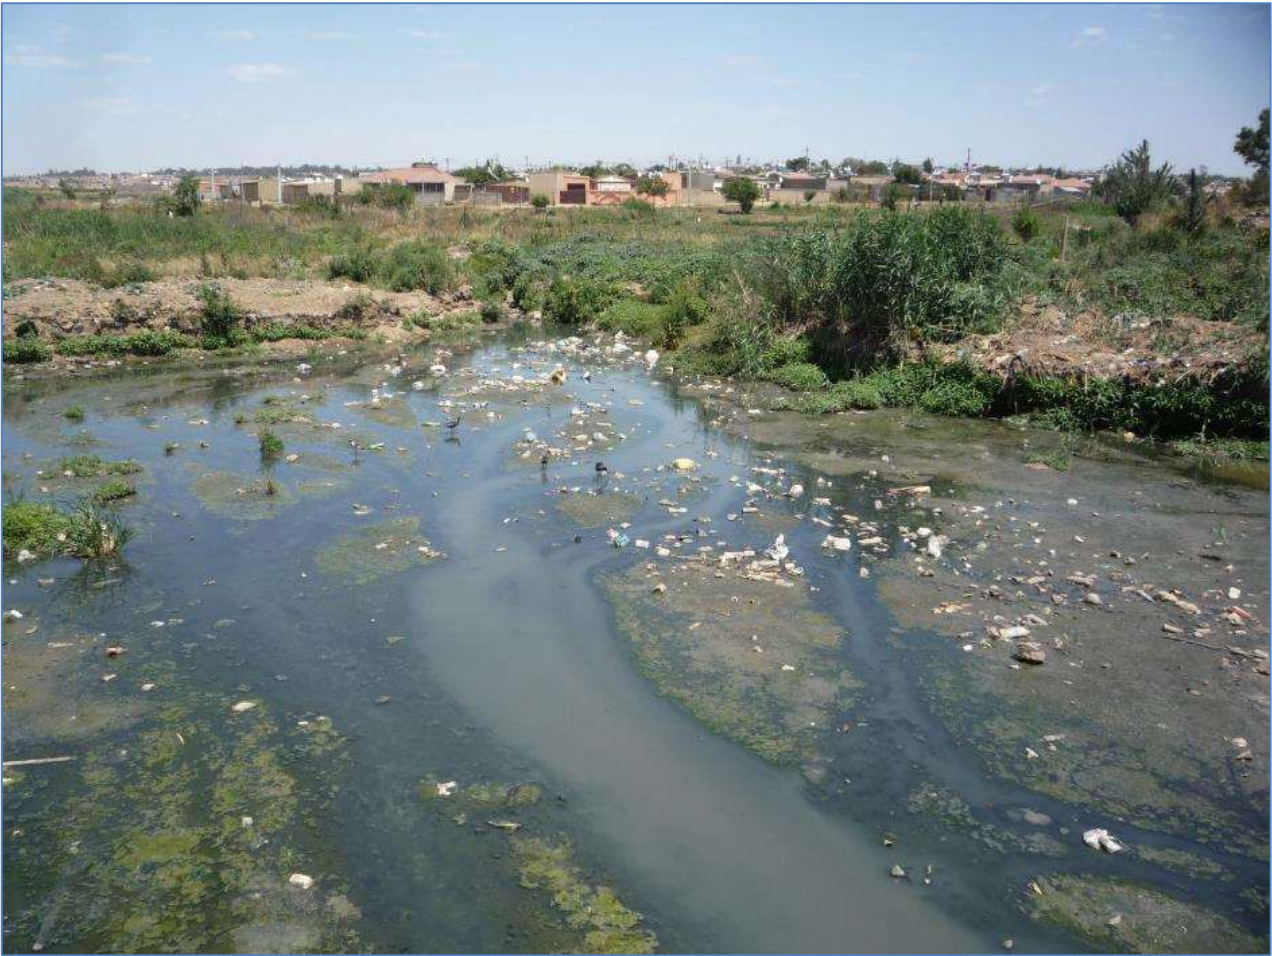
**Figure 46, position 15 (& 9): View west (upstream) from where Glassnose Street crosses and dams up the K2 Tributary, showing its confluence with where the K2c Tributary flows in from the north (right) between weed-infested banks; (cf. Fig. 28).**
