CHAPTER 1: INTRODUCTION AND PROBLEM STATEMENT

The main aim of this study is to establish the present water quality condition and hydrological status of the Hennops River. This will involve an examination of certain water quality constituents in terms of their suitability for the well-being of aquatic ecosystems as well as certain hydrological problems occurring within the Hennops River. This is only made possible by determining the status of its principal tributaries as well. Erosion of riverbanks and silting up of riverbeds are examples of hydrological problems. Water quality problems are measured against certain variables which are classified into physical, chemical and microbiological constituents. The values of the different constituents attained from collecting recorded sampling data are compared to the requirements needed by aquatic ecosystems for survival. The possible negative effects that increased urbanisation with associated activities have had on the Hennops River will also be ascertained. Rehabilitative and mitigatory measures will be proposed towards the improvement of the hydrological and water quality conditions of the Hennops River.

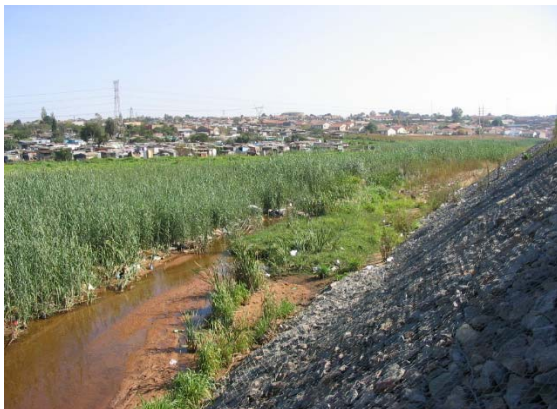
Figure 5: Kaalspruit flowing through Tembisa

The Kaalspruit flows near the western boundary of Tembisa (**Figure 5**) towards Olifantsfontein, where another tributary from the south-east enters the river. Their confluence is at the start of a wetland (known as the Olifantsfontein wetland) from where the Kaalspruit continues flowing north through an eroded channel of the wetland. This tributary has two sub-tributaries which enter Clayville at the southern boundary through two concrete channels (**Figure 6**). These two channels become one main stormwater channel through Clayville, hereafter known as the “Clayville tributary”. This channel consequently also receives run-off from industries and roads.

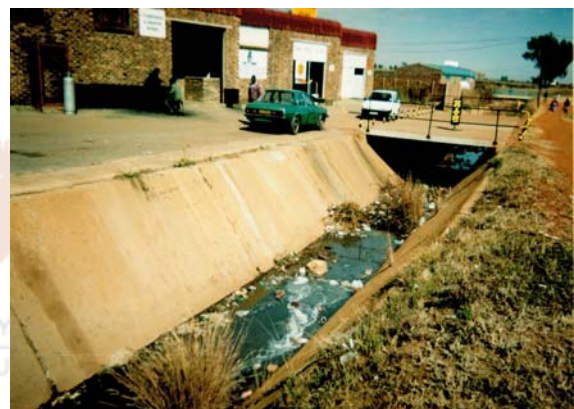
Figure 6: Clayville concrete channel

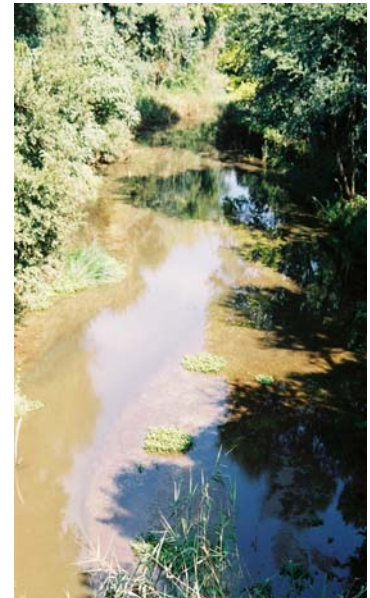
Figure 7: Sesmyspruit

The Rietvlei River feeds the Rietvlei Dam and the dam overflow and some return flow water from the waterworks downstream of the dam are the main source of water in the Sesmyspruit (**Figure 7**). The origin of the Rietvlei River down to and including the Rietvlei Dam does not form a significant part of this study as the influence of the Sesmyspruit on the Hennops River is handled in more detail.

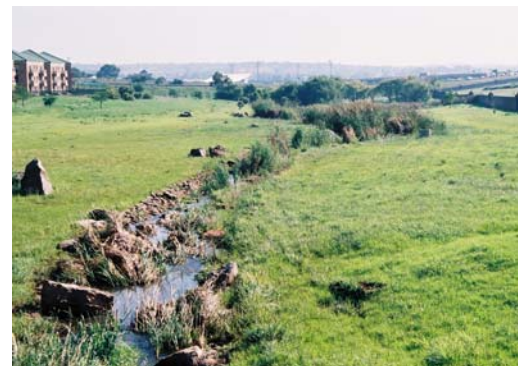
Figure 8: Hazelspruit flowing through Highveld Technopark

Another tributary in the form of the Kastaiingspruit, which becomes the Hazelspruit, flows from the south through Highveld Technopark and confluences with the Hennops River (**Figure 8**). This point is at the south-eastern edge of the Centurion Cricket Stadium, approximately 600 m upstream of the Centurion Lake. The River then passes between the Centurion Cricket Stadium and a recreational waterpark (called “Splash”) before entering the Centurion Lake below the Centurion Lake Hotel.

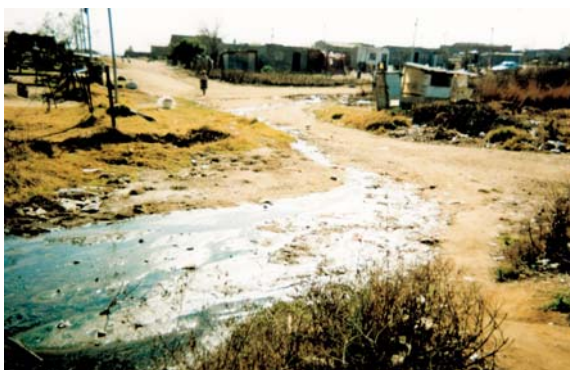
Figure 9: Non-point source pollution from informal settlements

Because the townships are littered with municipal general waste the stormwater augmented from these areas becomes a major contributor to the non-point source pollution entering the Kaalspruit during storms (**Figure 9**). Such wastes include cans, bottles and varying kinds of plastics. Phosphates, nitrates and pesticides could also be washed into the Kaalspruit due to the agricultural activities taking place in these areas illustrated by **Figure 10**.

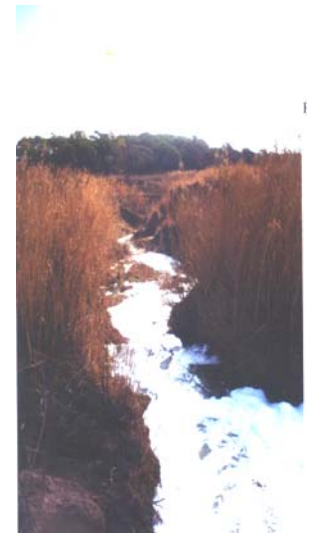
Figure 11: Clayville tributary before confluence with Kaalspruit

Clayville is the industrial centre of Midrand and lies north and downstream of the above-mentioned areas. Stormwater and run-off from paved areas discharge into the Clayville tributary which passes through the centre of Clayville in a northerly direction. As illustrated by **Figure 11** this tributary of the Kaalspruit is contaminated with any process water and leaking effluents from the industrial processes of Clayville. Visual observations reveal that there is a continuous flow of waste water in the channel even under dry weather conditions. According to Shepherd *et al.* (2000) most of the area's industrial effluent discharges into the sewer network to be treated with the domestic wastewater at the Olifantsfontein Sewage Works.

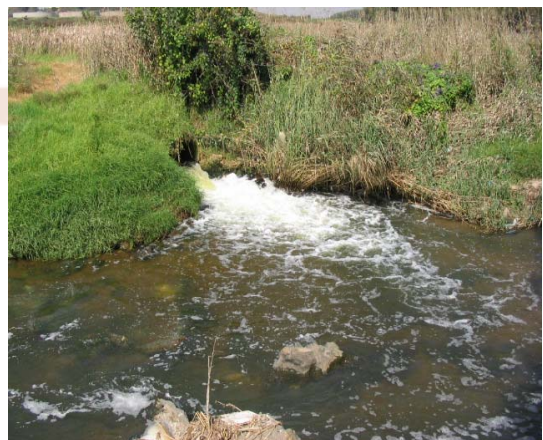
Figure 12: Point discharge from Olifantsfontein Sewage Works

The treated industrial effluent from the Olifantsfontein Sewage Works discharges as a point source pollutant into the Olifantspruit (**Figure 12**). In terms of hydrology, the Olifantspruit's flow regime is influenced as the sewage works' effluent return flow is a major contributor to the permanent flow in the Olifantspruit to later form the Hennops River. According to Rössle (2004) the volume of effluent return flow is in the order of 70 Mℓ/d with an anticipated volume of 120 Mℓ/d that could eventually be reached. The treatment works purifies the wastewater emanating from Tembisa, Ivory Park, Rabie Ridge, Clayville and Olifantsfontein.

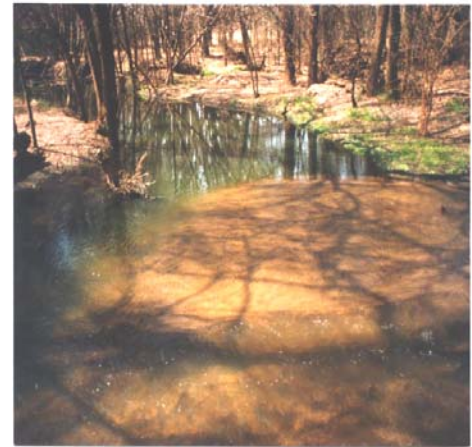
Figure 13: Confluence of Olifantspruit and Sesmyspruit

The Irene Country Club (golf course) borders slightly west of the confluence of the Sesmyspruit (emanating from Rietvlei Dam) and Olifantspruit. Visual observations have revealed (**Figure 13**) that substantial sedimentation from the Olifantspruit is occurring and that water from the Sesmyspruit seems to be substantially clearer. After the confluence of these two rivers the name changes to Hennops River. Water is extracted from the Hennops River for irrigating 60 ha of the golf course.

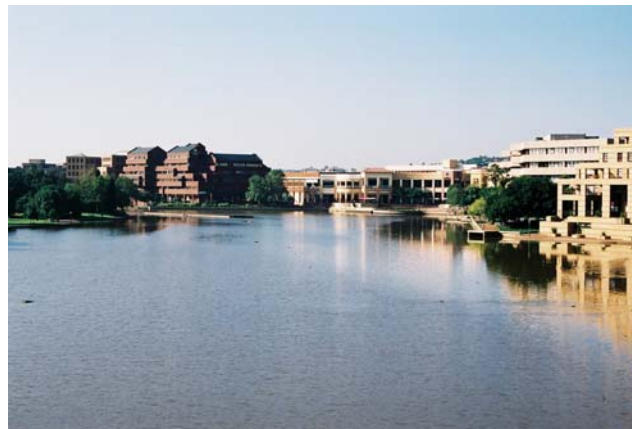
Figure 14: Centurion Lake forming the centre of the Centurion CBD

At present, anyone familiar with the Centurion Lake knows the lake is in a poor and problematic environmental state. It is silted-up in most places, occasional fish deaths occur, complaints about odours are common according to Lottering (2003)* and recreational activities have ceased. The lake has become a silt trap and pollution control facility for the upstream areas mentioned since the areas of Tembisa.

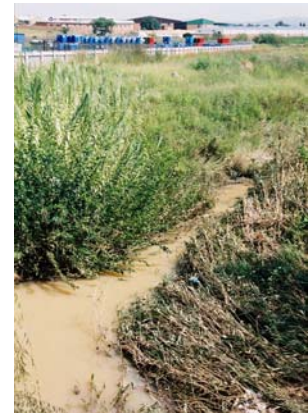
Figure 15: Rietspruit *en route* to Hennops River

The Hennops River exits the nature reserve, flows under the R55 road and is fed by the Rietspruit (**Figure 15**) before passing the Centurion Sewage Works. In terms of the River's hydrology the sewage works, as in the case of the Olifantsfontein Sewage Works, is a major contributor to the flow volume of the River. Botha (2004)* mentions that these works release between 38 and 60 Mℓ of effluent return flow to the Hennops River each day. According to Botha (2004)* the only concern for the sewage works concerning water quality is the release of high amounts of phosphates but the situation is continually monitored.
